NUMBER: 31-002-13

GROUP: Collision Bulletin

Blending Clearcoat During The Refinish Process

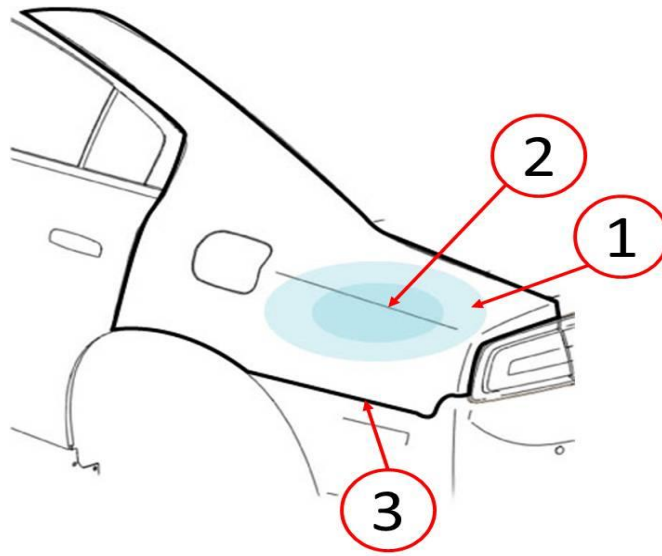
Fig. 1 Clearcoat Blended Panel

Partial clearcoat blending is not an approved warranty repair process for Chrysler vehicles. Partial clearcoat blending is a process that generally involves adding solvents to a paint manufacturers clearcoat mixing formula to reduce the viscosity. This will not only degrade the durability of materials but it could also produce additional emissions. Partial clearcoat blending is achieved by adopting processes that are typically used to transition basecoat color on repair areas. Clearcoat should always be applied to the entire surface area of a body panel and mixed to manufacturers specifications. Any vehicle repaired with the partial clearcoat blending process will prematurely fail and eventually result in a clearcoat delamination condition. An example of clearcoat blending is shown in ([Fig. 1](#)).

- 1 - Clearcoat
- 2 - Basecoat
- 3 - Left Quarter Panel

As shown in (Fig. 1) clearcoat is not applied to the entire quarter panel surface area, but only to a small portion. The repair area will initially appear sufficient but depend on how the process was performed the repair area will begin to degrade in 6 months to 3 years. Clearcoat (1) has been applied to the entire quarter panel in (Fig. 2) and basecoat (2) was applied to cover the repair area, which is the proper repair process.

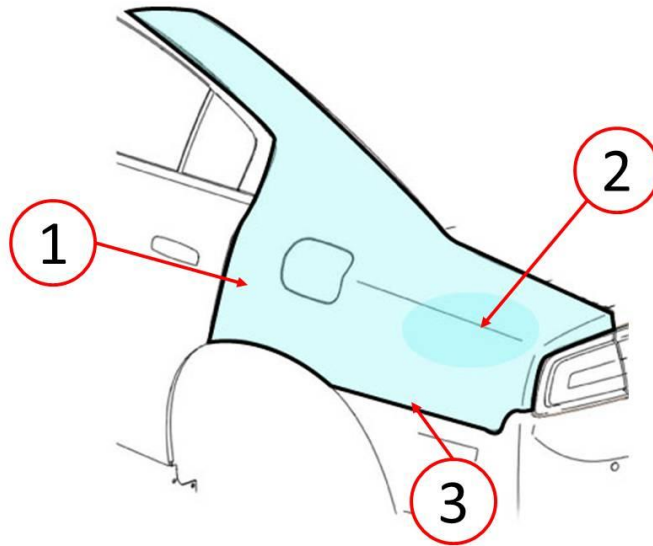
Fig. 2 Complete Application

- 1 - Clearcoat
- 2 - Basecoat
- 3 - Left Quarter Panel

NOTE: This figure is used for demonstration purposes only. Most quarter panel repairs require clearcoat to be applied to the entire side aperture which typically ends at the cowl adjacent to the front fender.
