NUMBER: 31-001-20

GROUP: 31 - Collision Bulletins

Blending Clearcoat During The Refinish Process

1996 - Current (All) All FCA Group Vehicles

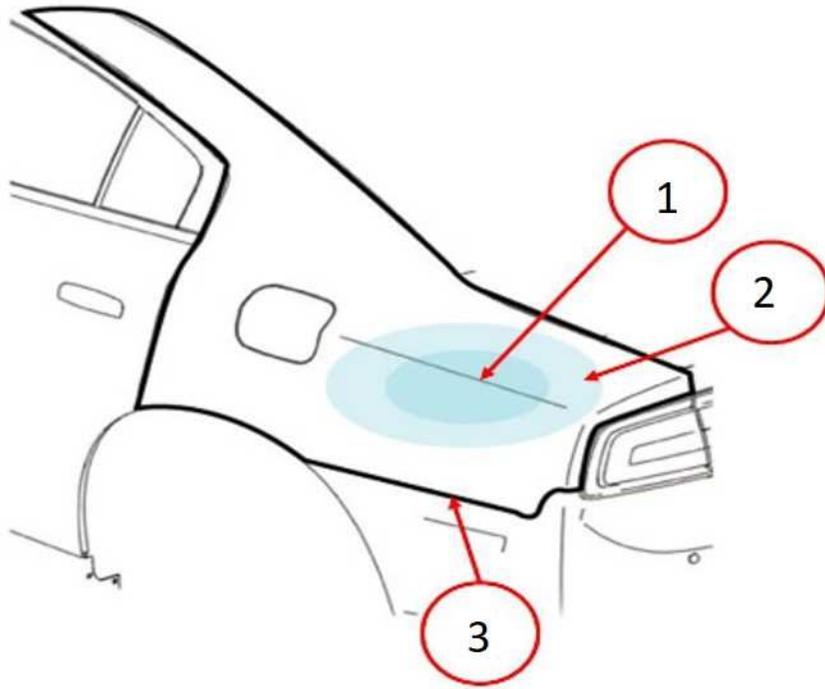
Fig. 1
Partial Clearcoat Blended Panel

- Partial clearcoat blending is a process that generally involves adding solvents to a paint manufacturers clearcoat mixing formula to reduce the viscosity. This will not only degrade the durability of materials but it could also produce additional emissions.
- Partial clearcoat blending is achieved by adopting processes that are typically used to transition basecoat color on repair areas.
- Clearcoat should always be applied to the entire surface area of a body panel and mixed to manufacturers specifications.
- Any vehicle repaired with the partial clearcoat blending process will prematurely fail and eventually result in a clearcoat delamination condition.
- An example of partial clearcoat blending is shown in (Fig. 1) .

As shown in (Fig. 1) clearcoat is not applied to the entire quarter panel surface area, but only to a small portion. The repair area will initially appear sufficient but depending on how the process was performed the repair area will begin to degrade in 6 months to 3 years.

Partial clearcoat blending is not an approved warranty repair process for FCA vehicles.

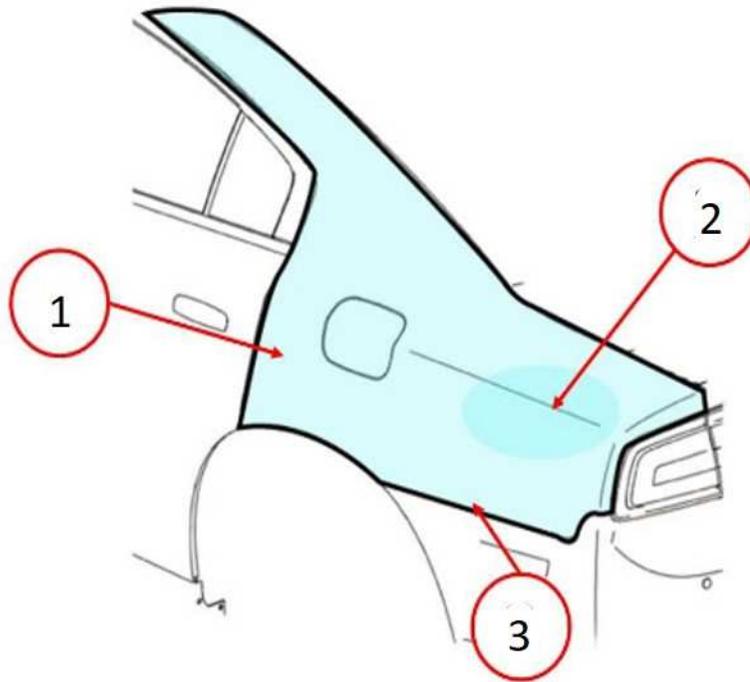
Fig. 2
Complete Application

Clearcoat has been applied to the entire quarter panel in (Fig. 2) and basecoat was applied to cover the repair area, which is the proper repair process.

NOTE: This figure is used for demonstration purposes only. Most quarter panel repairs require clearcoat to be applied to the entire side aperture which typically ends at the cowl adjacent to the front fender.
