Technical Service Bulletin

Mazda North American Operations
Irvine, CA 92618-2922

Subject: MULTIPLE ELECTRICAL MALFUNCTIONS AFTER BODY REPAIR	Bulletin No.: 09-035/18
	Last Issued: 09/14/2018

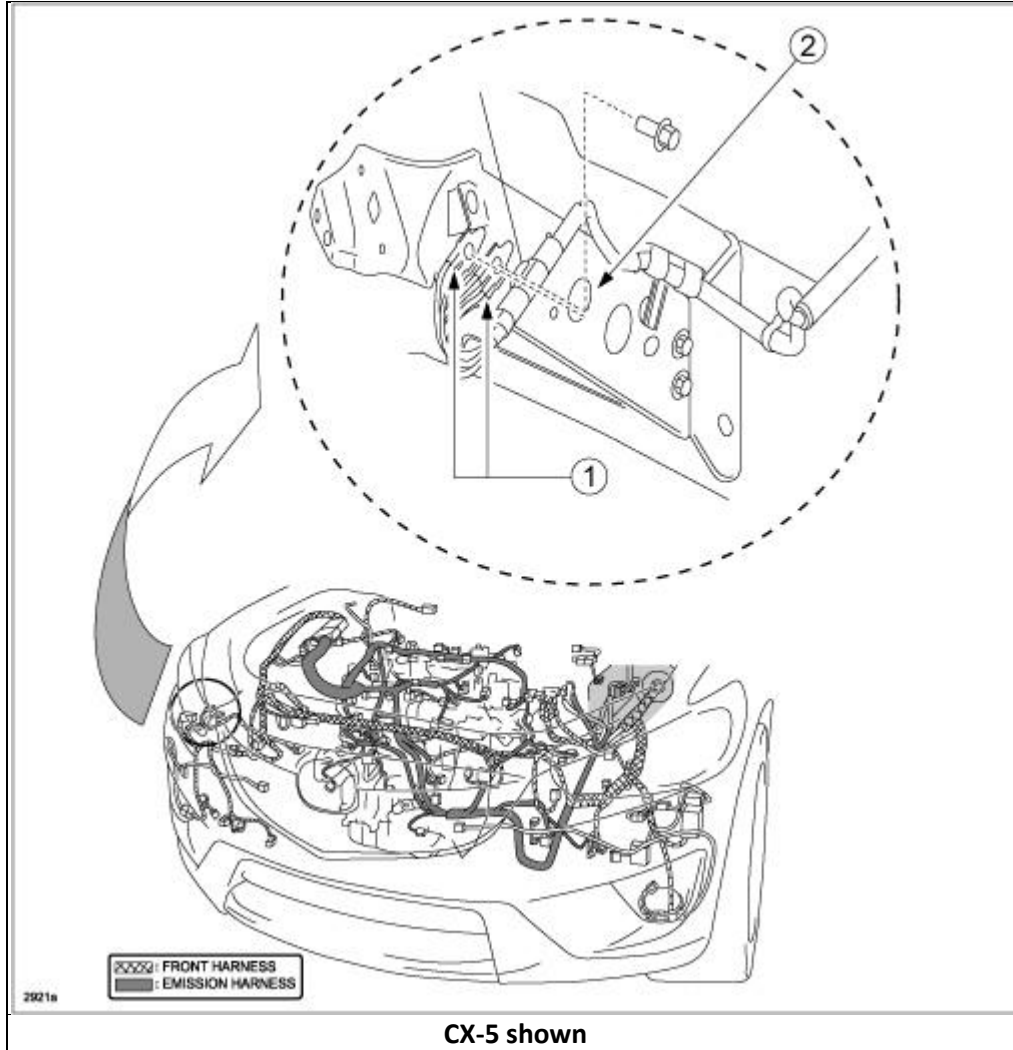
Some customers may experience **one or more electrical malfunctions** after a vehicle body repair. The newly painted fender stay (2) may be causing a poor front harness (1) ground connection.
