# RCI-30-25-001-1 High Voltage (HV) Battery Handling and Damage Inspection Guidelines

## Rivian Automotive, LLC - Service Guideline

Document Type	Collision Repair Information Document
Date	November 21, 2025
Affected Region(s)	North America, Europe
Affected Model(s)	R1T, R1S, EDV
Model Year(s)	2022+
Vehicle System	30 - High Voltage Battery

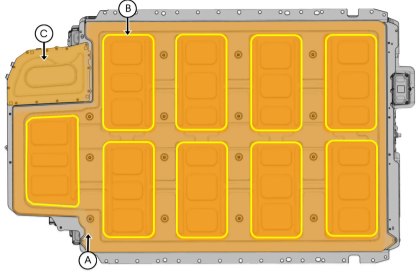
Model	Model Year	Variant/ Battery Type	Damage Guidelines	Figure
	2025+	Large and Max Pack/On-Road and Off-Road	<p><b>Bottom Cover Components:</b></p> <ul style="list-style-type: none"> <li>A. Stamped Aluminum Panel(s)</li> <li>B. Acceptable Deformation Area(s)</li> <li>C. HVDB Cover</li> </ul> <p>The HV battery pack bottom covers are composed of stamped aluminum panels. The replaceable skid plates provide the internal battery components with protection from direct impact. The HVDB cover is replaceable. Inspect the internal components of the HVDB for damage prior to replacing the cover.</p> <ul style="list-style-type: none"> <li>• <b>Scratches or Gouges</b> <ul style="list-style-type: none"> <li>◦ Less than 0.5mm in depth on the stamped aluminum bottom cover are acceptable when refinished.</li> <li>◦ Less than 1mm in depth on the cast or extruded sides of the battery housing are acceptable when refinished.</li> </ul> </li> <li>• <b>Deformations</b> <ul style="list-style-type: none"> <li>◦ Up to 5mm of depth on the stamped aluminum bottom are allowed only within the acceptable deformation area(s). No deformation damage is allowed outside of the acceptable deformation area(s) unless signed off by Rivian. Contact your regional Rivian Collision/Service Team for more information or assistance with repair.</li> <li>◦ No deformation is acceptable on the top or sides of the HV battery housing unless signed off by Rivian. Contact your regional Rivian Collision/Service Team for more information or assistance with repair.</li> </ul> </li> <li>• <b>Threaded fastener damage</b> <ul style="list-style-type: none"> <li>◦ Thread damaged rivnuts or rivstuds on the exterior flanges of the HV battery housing can be replaced only when there is no deformation damage adjacent to the fastener. For cases where there is deformation damage adjacent to the fastener, contact your regional Rivian Collision/Service Team to request more information or assistance with repair.</li> <li>◦ Replacement of damaged rivnuts and rivstuds installed into the main body of the HV battery housing need to be reviewed and signed off by Rivian. Contact your regional Rivian Collision/Service Team for more information or assistance with repair.</li> <li>◦ Thread damage in the casting can be repaired with time-serts for only M6 sized bolts and smaller.</li> </ul> </li> </ul>

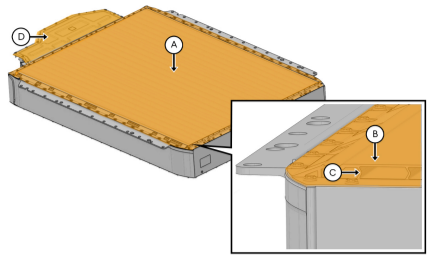
Model	Model Year	Variant/ Battery Type	Damage Guidelines	Figure
		Standard	<p><b>Bottom Cover Components:</b></p> <ul style="list-style-type: none"> <li>A. Bottom Cover</li> <li>B. Outer Wall</li> <li>C. Internal Vertical Supports</li> <li>D. HVDB Cover</li> </ul> <p>The HV battery pack bottom cover is composed of an extruded aluminum panel with a raised double wall to protect the internal battery components from direct impact. The outer wall is supported by regularly spaced internal vertical supports that run the length of the pack. The position of these vertical supports along the width of the pack can be identified by the exposed extrusion profile at the rear edge of the bottom panel. The HVDB cover is replaceable. Inspect the internal components of the HVDB for damage prior to replacing the cover.</p> <ul style="list-style-type: none"> <li>• <b>Scratches or gouges</b> <ul style="list-style-type: none"> <li>◦ Scratches or gouges less than 0.75mm in depth on the battery housing and bottom cover are acceptable when refinished.</li> </ul> </li> <li>• <b>Deformations</b> <ul style="list-style-type: none"> <li>◦ No deformation damage on the outer wall of the bottom cover is acceptable within 5mm of the vertical support walls. No deformation damage to the inner wall or single wall portion of the bottom cover is acceptable.</li> <li>◦ Up to 5mm of depth on the outer wall are acceptable as long as the deformed area does not encroach on the restrictions defined around the vertical support walls. Contact your regional Rivian Collision/Service Team to request more information or assistance with repair.</li> <li>◦ No deformation damage is allowed on the top or sides of the HV battery housing unless signed off by Rivian. Contact your regional Rivian Collision/Service Team to request more information or assistance with repair.</li> </ul> </li> <li>• <b>Threaded Fastener Damage</b> <ul style="list-style-type: none"> <li>◦ Thread damaged rivnuts and rivstuds on the exterior flanges of the battery housing can be replaced if there is no deformation damage adjacent to the fastener. For cases where there is deformation damage adjacent to the fastener, contact your regional Rivian Collision/Service Team to request more inform</li> <li>◦ Replacement of damaged rivnuts or rivstuds installed into the main body of the HV battery housing need to be reviewed and signed off by Rivian. Contact your regional Rivian Collision/Service Team to request more information or assistance with repair.</li> </ul> </li> </ul>
