Technical Service Bulletin (TSB)
Door Hem Aluminum Body Panel Corrosion Repair

REFERENCE:	TSB: 31-001-26 REV. A GROUP: 31 - Collision	Date:	February 21, 2026	REVISION:	31-001-26
VEHICLES AFFECTED:	2018 - 2026 (JL) Jeep Wrangler 2020 - 2026 (JT) Jeep Gladiator			MARKET APPLICABILITY: <input checked="" type="checkbox"/> NA <input checked="" type="checkbox"/> MEA <input checked="" type="checkbox"/> SA <input checked="" type="checkbox"/> IAP <input checked="" type="checkbox"/> EE <input checked="" type="checkbox"/> CH NOTE: This bulletin applies to North America, Enlarged Europe, China, Middle East & Africa and South America markets.	
CUSTOMER SYMPTOM:	Customers may experience the following: <ul style="list-style-type: none"> Filiform corrosion at the hem area of the door. 				
CAUSE:	Corrosion

This bulletin involves removing corrosion and refinishing the hem area on the vehicle door.

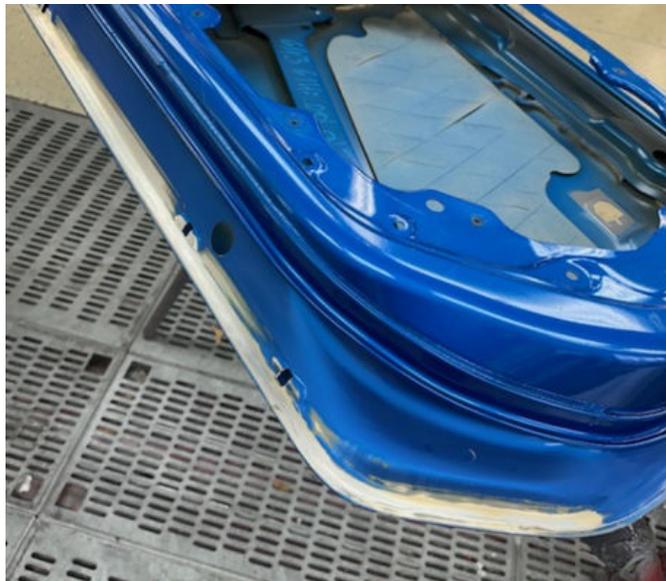
1. Remove door and place on a padded stand to protect the A-side surface of the door.
2. Remove the trim panel and carrier plate. Hinges can remain in place.
3. Remove factory applied seam sealer and clean any pitted areas using a 3M Clean & Strip disc or equivalent abrasive wheel.
4. Feather edge the existing OEM coating area beyond the bare aluminum areas with 320-400 grit sandpaper
[Fig. 1](#).

Fig. 1
Door Removed

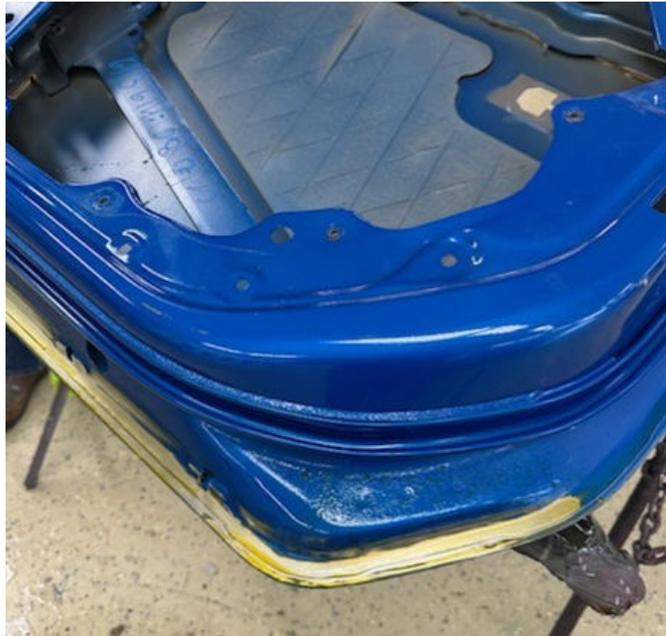
Fig. 2

5. Apply PPG's SX533 Aluminum Cleaner, or equivalent, using a 1:3 mix ratio with water using an acid-resistant brush or synthetic scuff pad, paying close attention to the deeply pitted areas [Fig. 2](#). Allow to react two to three minutes before rinsing with cool, clean water. Rinse water should rinse over the entire surface being treated.

Aluminum Cleaner Applied

6. Apply PPG's SX503 Aluminum Conditioner or equivalent, as packaged. Allow to react for one to three minutes, until a golden or tan color appears. Rinse well with cool, clean water and dry thoroughly [Fig. 2](#).
7. Clean the area to be refinished with mild soap and water and wax and grease remover prior to masking.
8. Mask the inside of the door using the reverse taping technique around the outer perimeter of the door to reduce any edge build-up of paint material [Fig. 3](#).

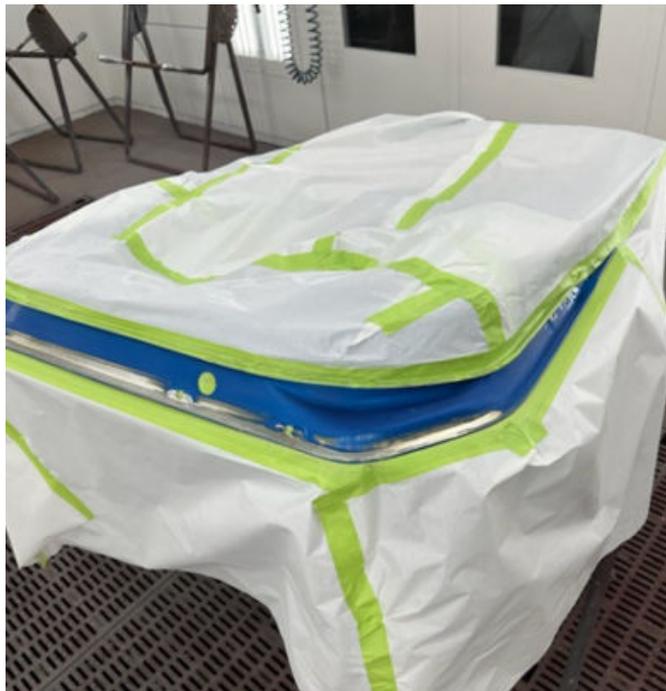
Fig. 3

Area Masked

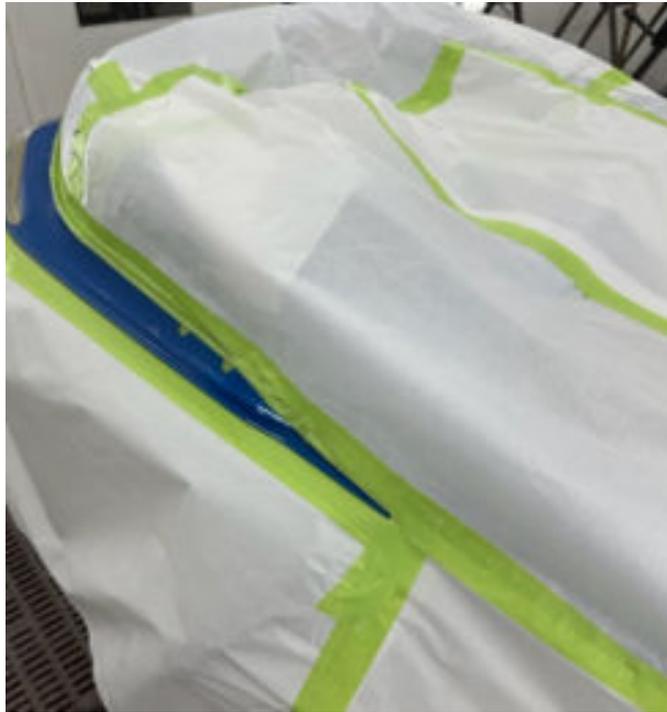
9. Prepare a narrow blend area on both sides of the door in the area shown [Fig. 4](#) and [Fig. 5](#).

Fig. 4
Narrow Blend Area

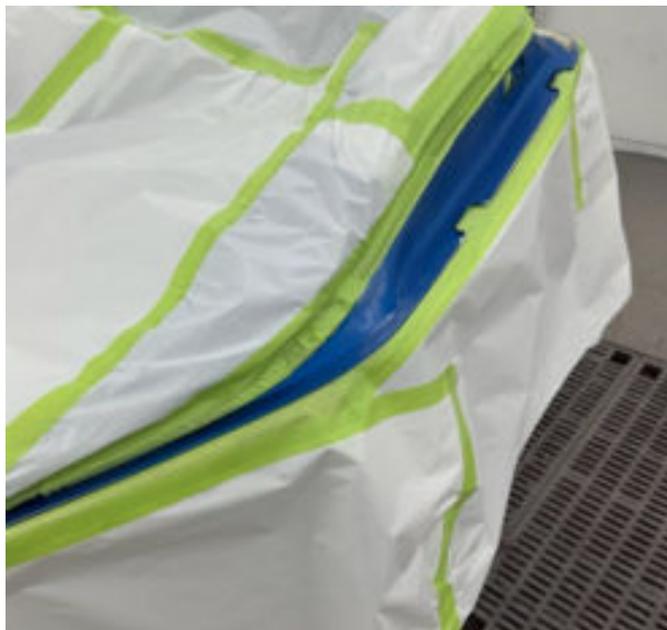
Fig. 5
Narrow Blend Area

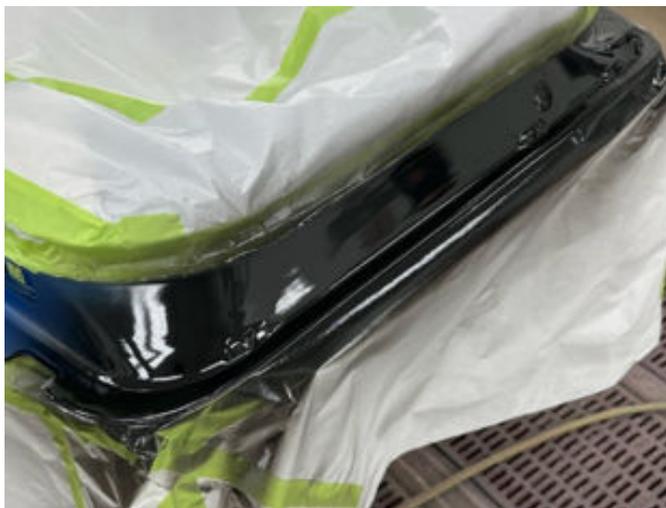
10. Apply one to two coats of F4921 Epoxy Primer or equivalent [Fig. 6](#).

Fig. 6
Epoxy Primer

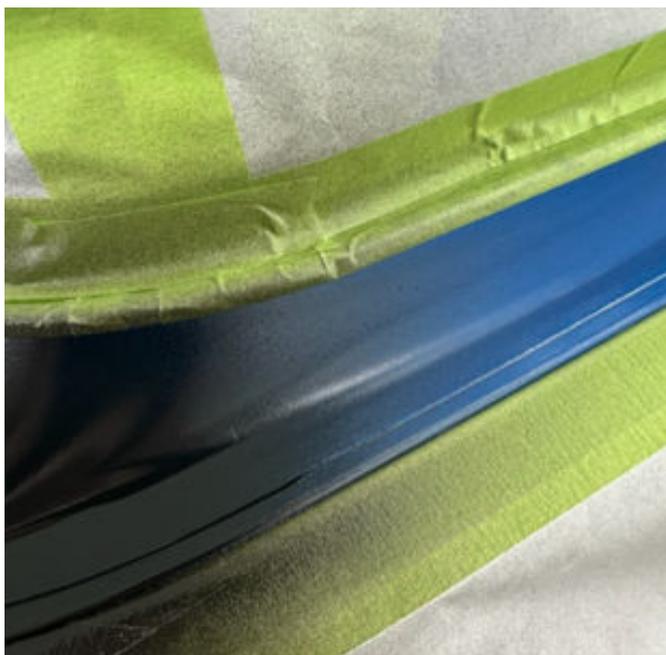
11. Melt in the edges of the epoxy primer [Fig. 7](#).

Fig. 7
Melted Edges Of Epoxy Primer

Allow one-hour dry time or force dry for 25 min at 60 °C (140 °F) for the epoxy primer to dry before applying seam sealer.

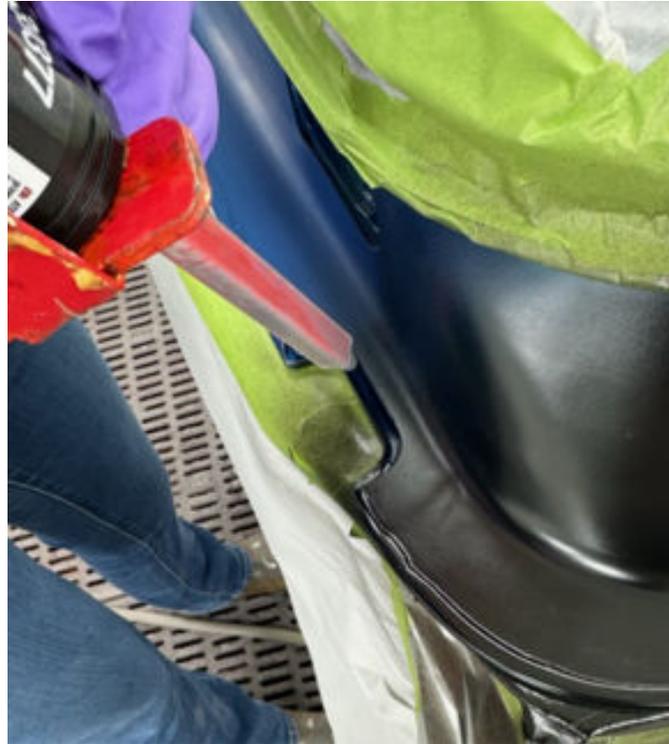
Fig. 9

12. Apply 2K seam sealer in the hinge opening areas and along the entire exposed hem seam [Fig. 8](#), reducing the width and feathering the seam sealer just prior to both blend areas [Fig. 9](#) and [Fig. 10](#).

Seam Sealer

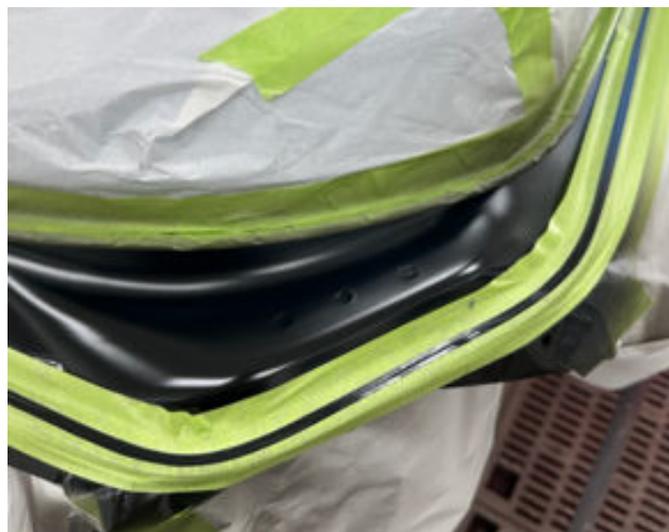
Fig. 10

Seam Sealer Drying

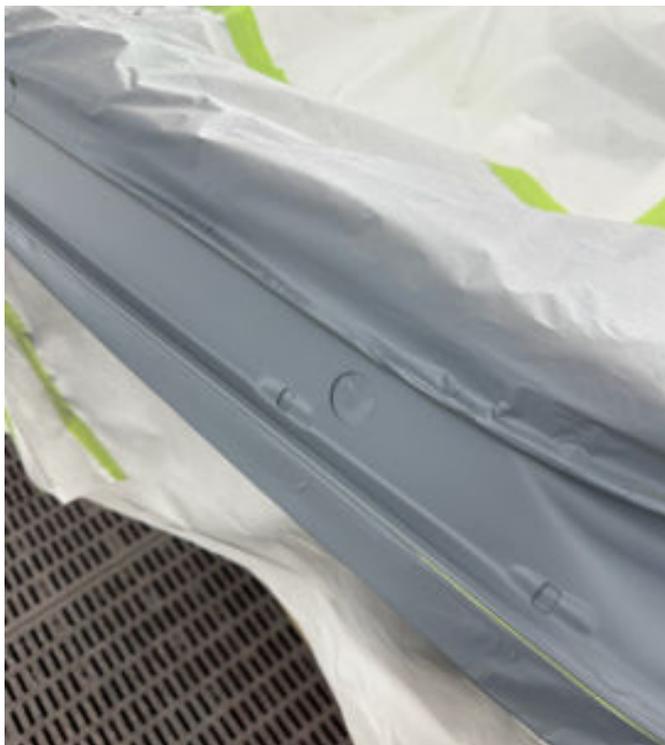
13. Apply primer sealer for uniform hiding and adhesion prior to basecoat [Fig. 11](#).

Fig. 11
Primer Sealer

NOTE: If pits or sanding/grinding marks are noticeable, apply primer surfacer (not shown) to achieve filling.

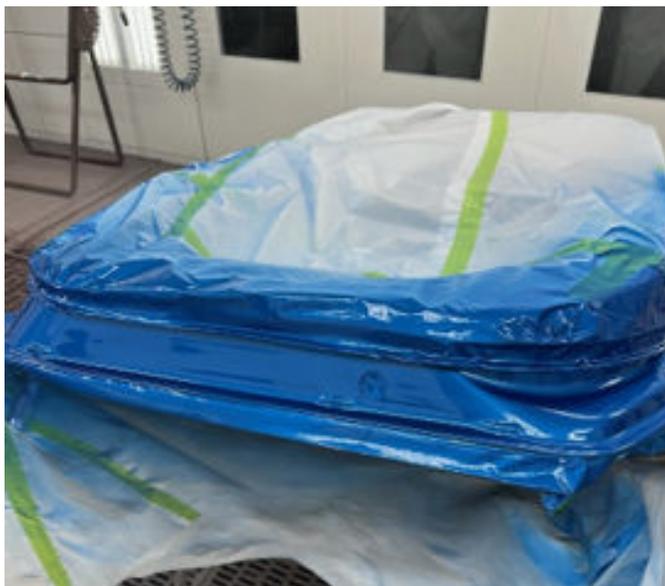
14. Apply basecoat color to achieve hiding and color match, blend color then clearcoat [Fig. 12](#).

Fig. 12
Blended Color And Clearcoat

NOTE: Allow clearcoat to air dry overnight or force dry for 25 minutes at 60 °C (140 °F).

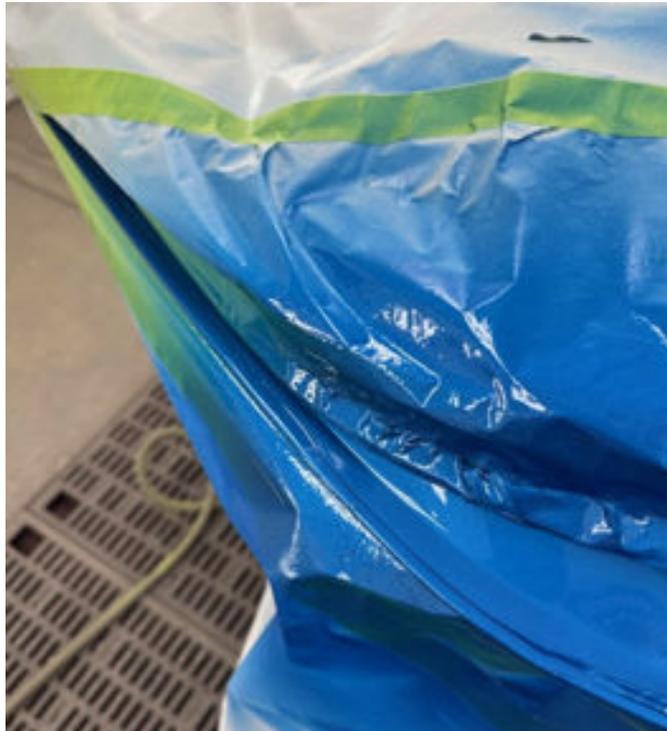
15. Melt in clearcoat overspray in the blend area [Fig. 13](#), [Fig. 14](#) and [Fig. 15](#).

Fig. 13
Melting In Clearcoat Overspray

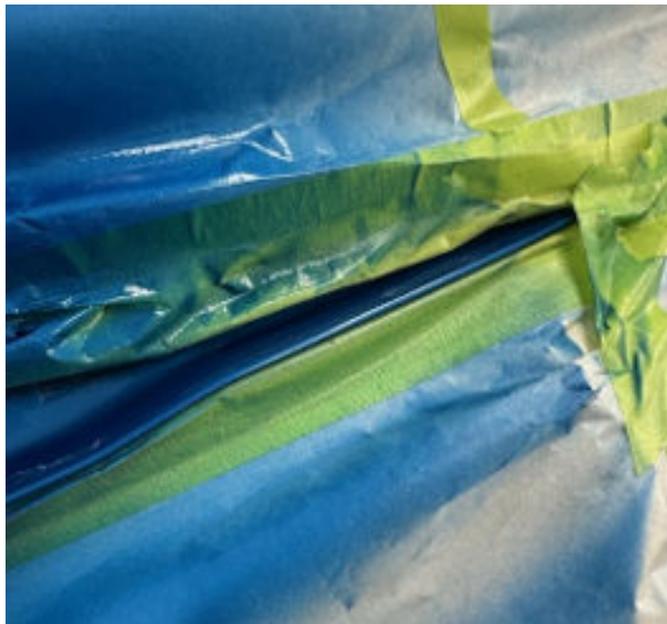
Fig. 14
Melting In Clearcoat Overspray

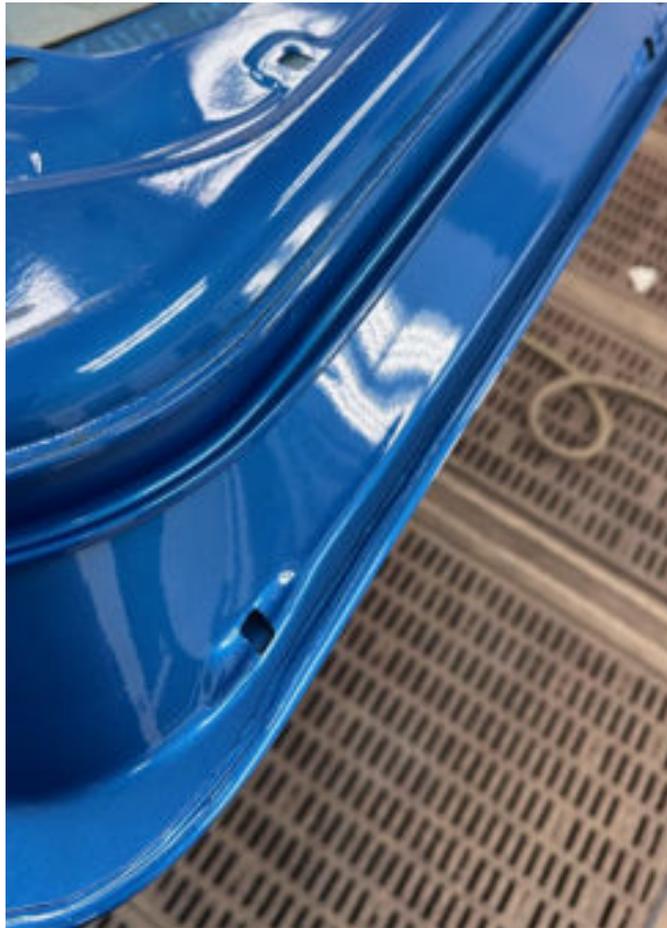
Fig. 15

Melting In Clearcoat Overspray

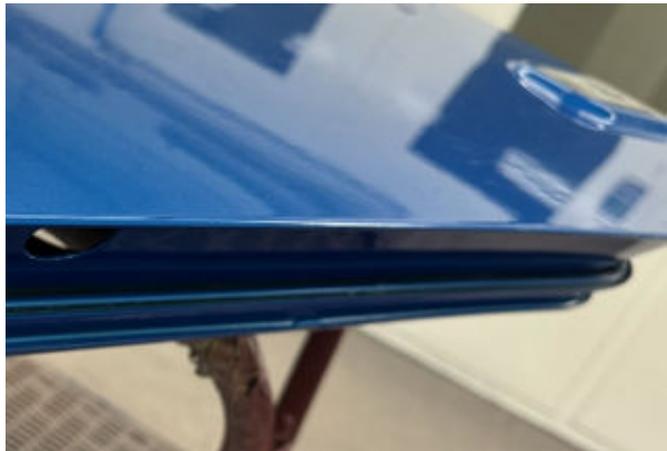
Fig. 16

16. Check for clearcoat buildup on the edge of the hem [Fig. 16](#).

Edge Of Hem

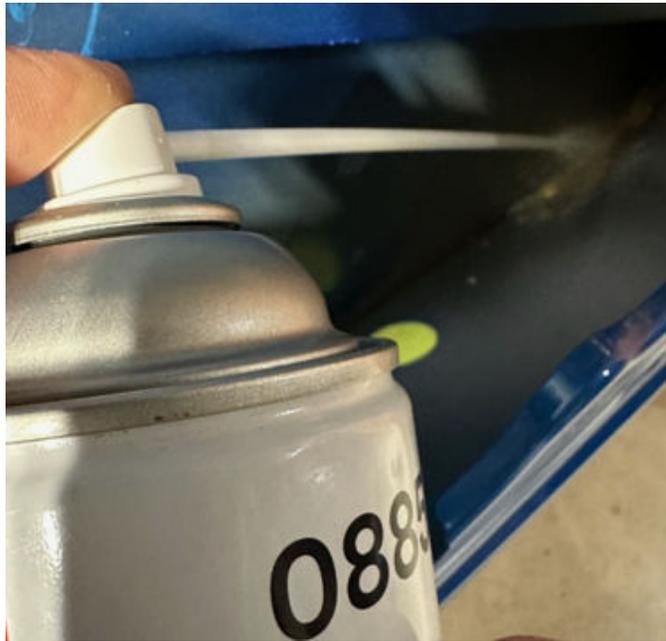
17. Apply masking tape to drain holes/openings at the bottom of the door as shown to prevent overspray.
18. Apply 3M's Cavity Wax or equivalent to the inside of the door shell between the door skin and door shell frame [Fig. 17](#).

Fig. 17
Applying Cavity Wax
