## Body Repair Tech Note: Repair Plastic Components

Non-safety related plastic components can be repaired using industry standard tools and methods, such as nitrogen welding or two-part adhesive designed for plastic repair.

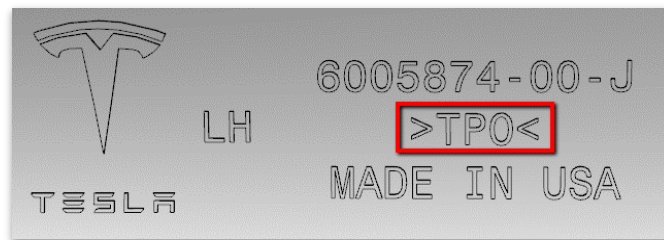
Figure 1 (Example of abbreviation)

Identify the plastic material of the component prior to repair. Inspect each component for an abbreviation that identifies the component material (Figure 1).

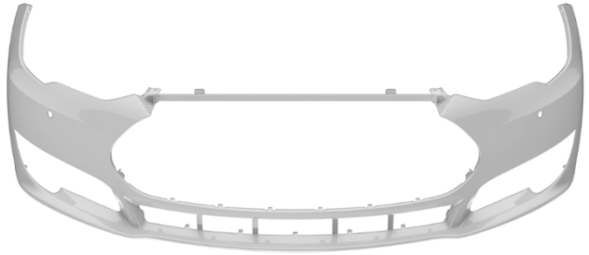
Description	Material	Image
Front Fascia	Thermoplastic Olefin (TPO)

<p><b>⚠ CAUTION:</b> Plastic repairs are not allowed in the radar area for Model S built after April 2016 and all Model X. Refer to <a href="#">BR-17-10-004</a>, "Repair Guidelines for Front Bumper Fascias" for more information.</p>
Rear Fascia	Thermoplastic Olefin (TPO)

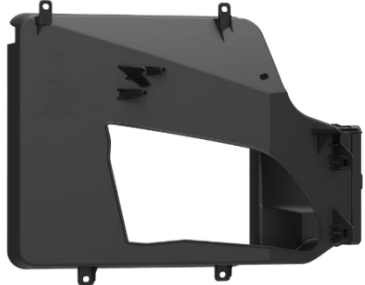
Ducting Assembly	Polypropylene with 30% Glass-fiber Filler (PP-GF30)

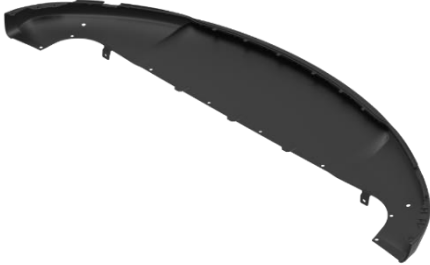
Lower Valance	Thermoplastic Olefin (TPO)

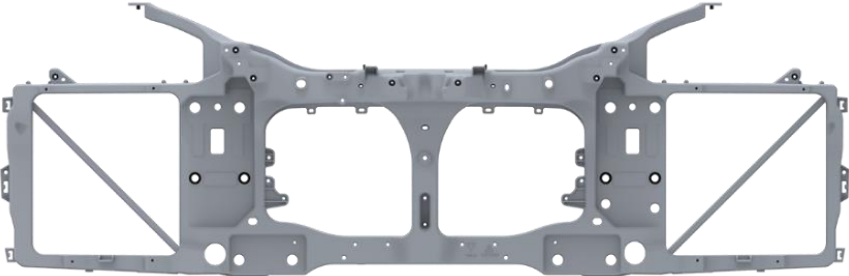
Front Carrier	Polypropylene with 40% Glass-fiber Filler (PP-GF40)

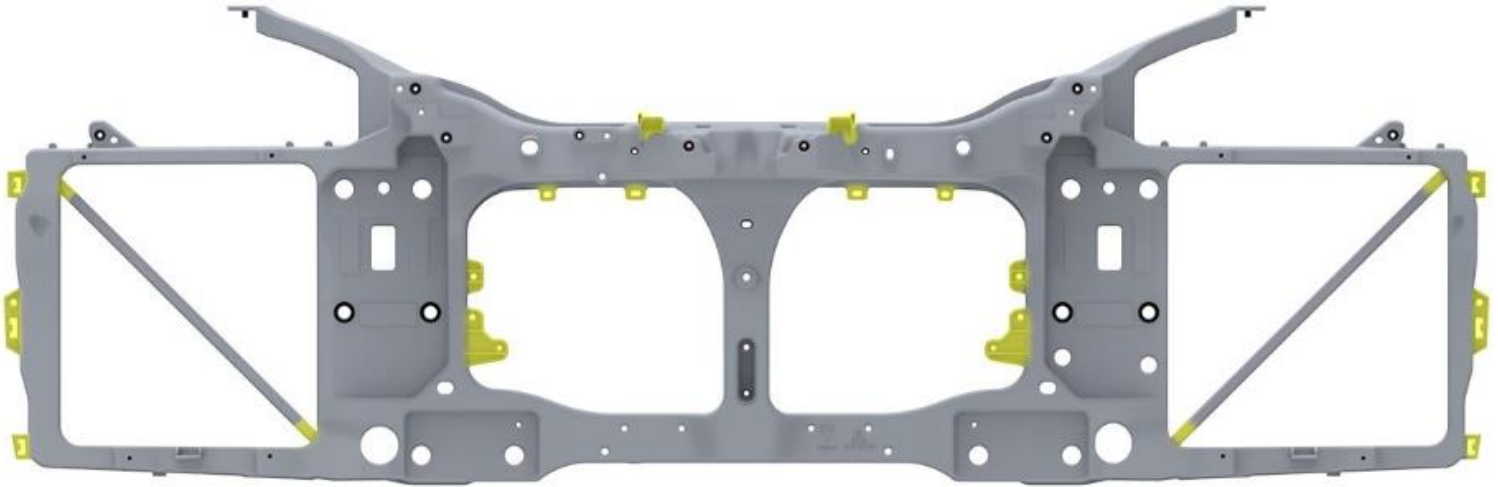
**Figure 1 (Front carrier repairable areas)**

The areas highlighted in yellow on the composite front carrier (Figure 2) can be repaired. Do not repair the front carrier if the damage extends beyond the highlighted areas.

**NOTE:** The front carrier on Model S Rear Wheel Drive vehicles built before April 2016 is made of magnesium, not plastic. Do not use these instructions to repair a magnesium front carrier.
