RCI-52-22-012-3: EDV Material Matrix and Repair Guide

Rivian Automotive, LLC Service Document

Document Type	Collision Repair Information Document
Date	March 14, 2024
Affected Region(s)	USA
Affected Model(s)	EDV
Model Year(s)	2022+
Vehicle System	52 - Body

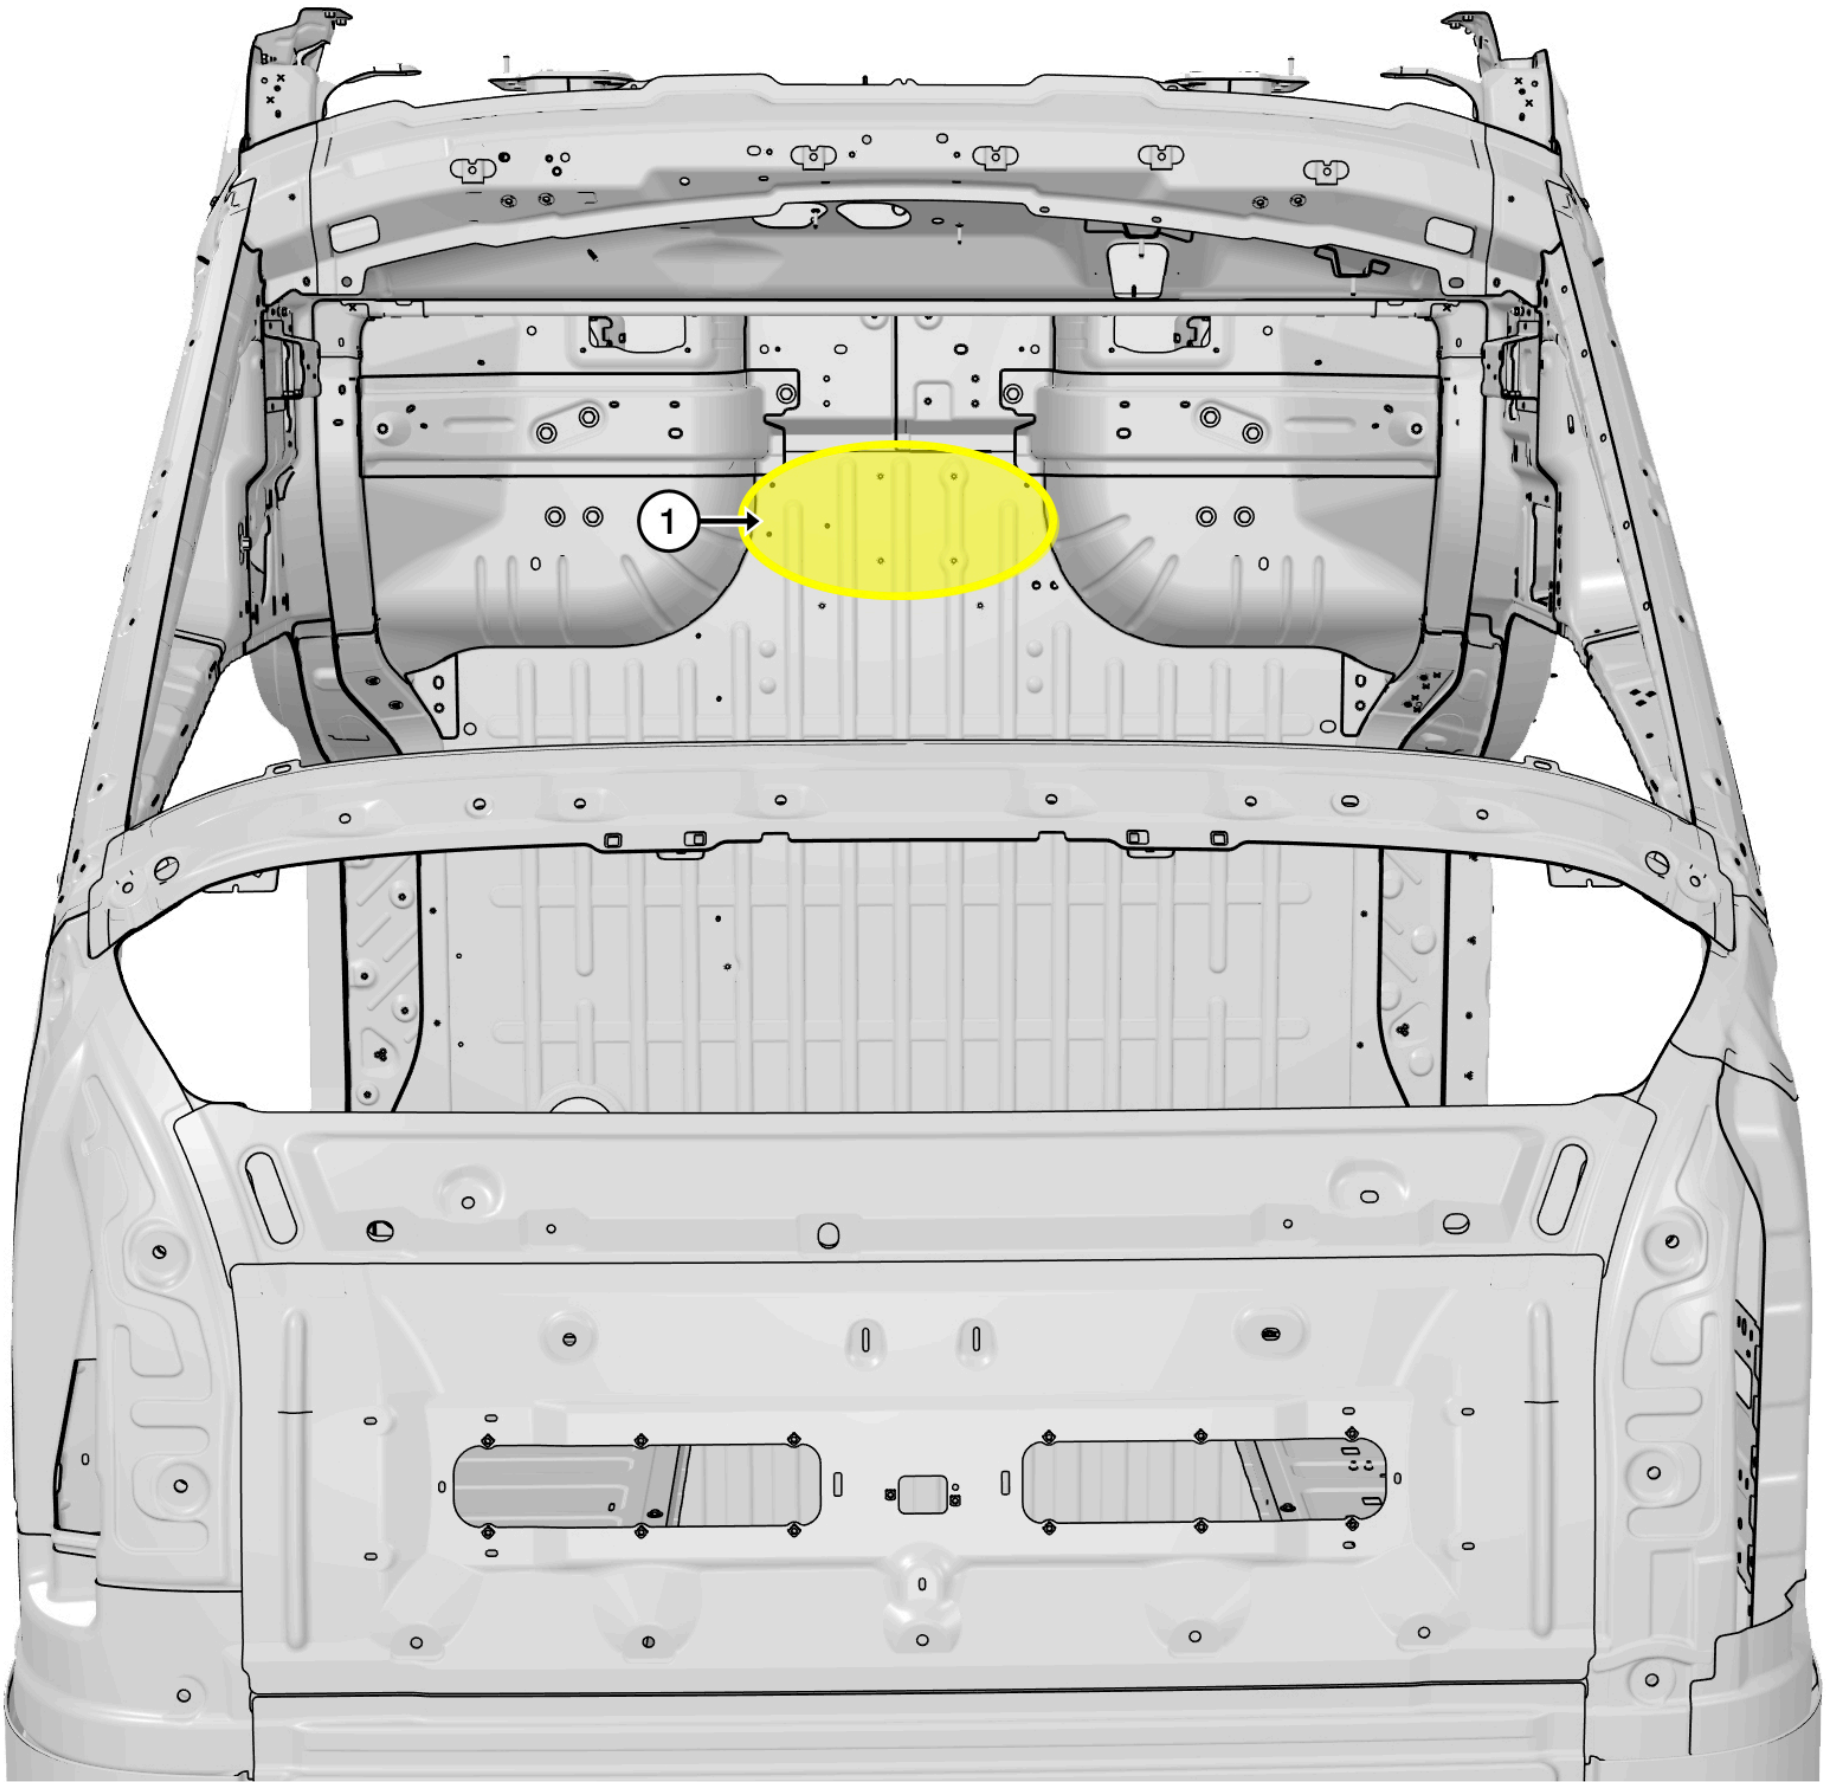
Number	Component
1	Floor Main Cab, Front

The front floor panel may experience deformation in minor front end impacts. Cosmetic repair of this damage within the material repair guidelines is recommended instead of full component replacement, provided there are no indications of more damage to the underlying structure, or other concerns that would require replacement of the entire panel.

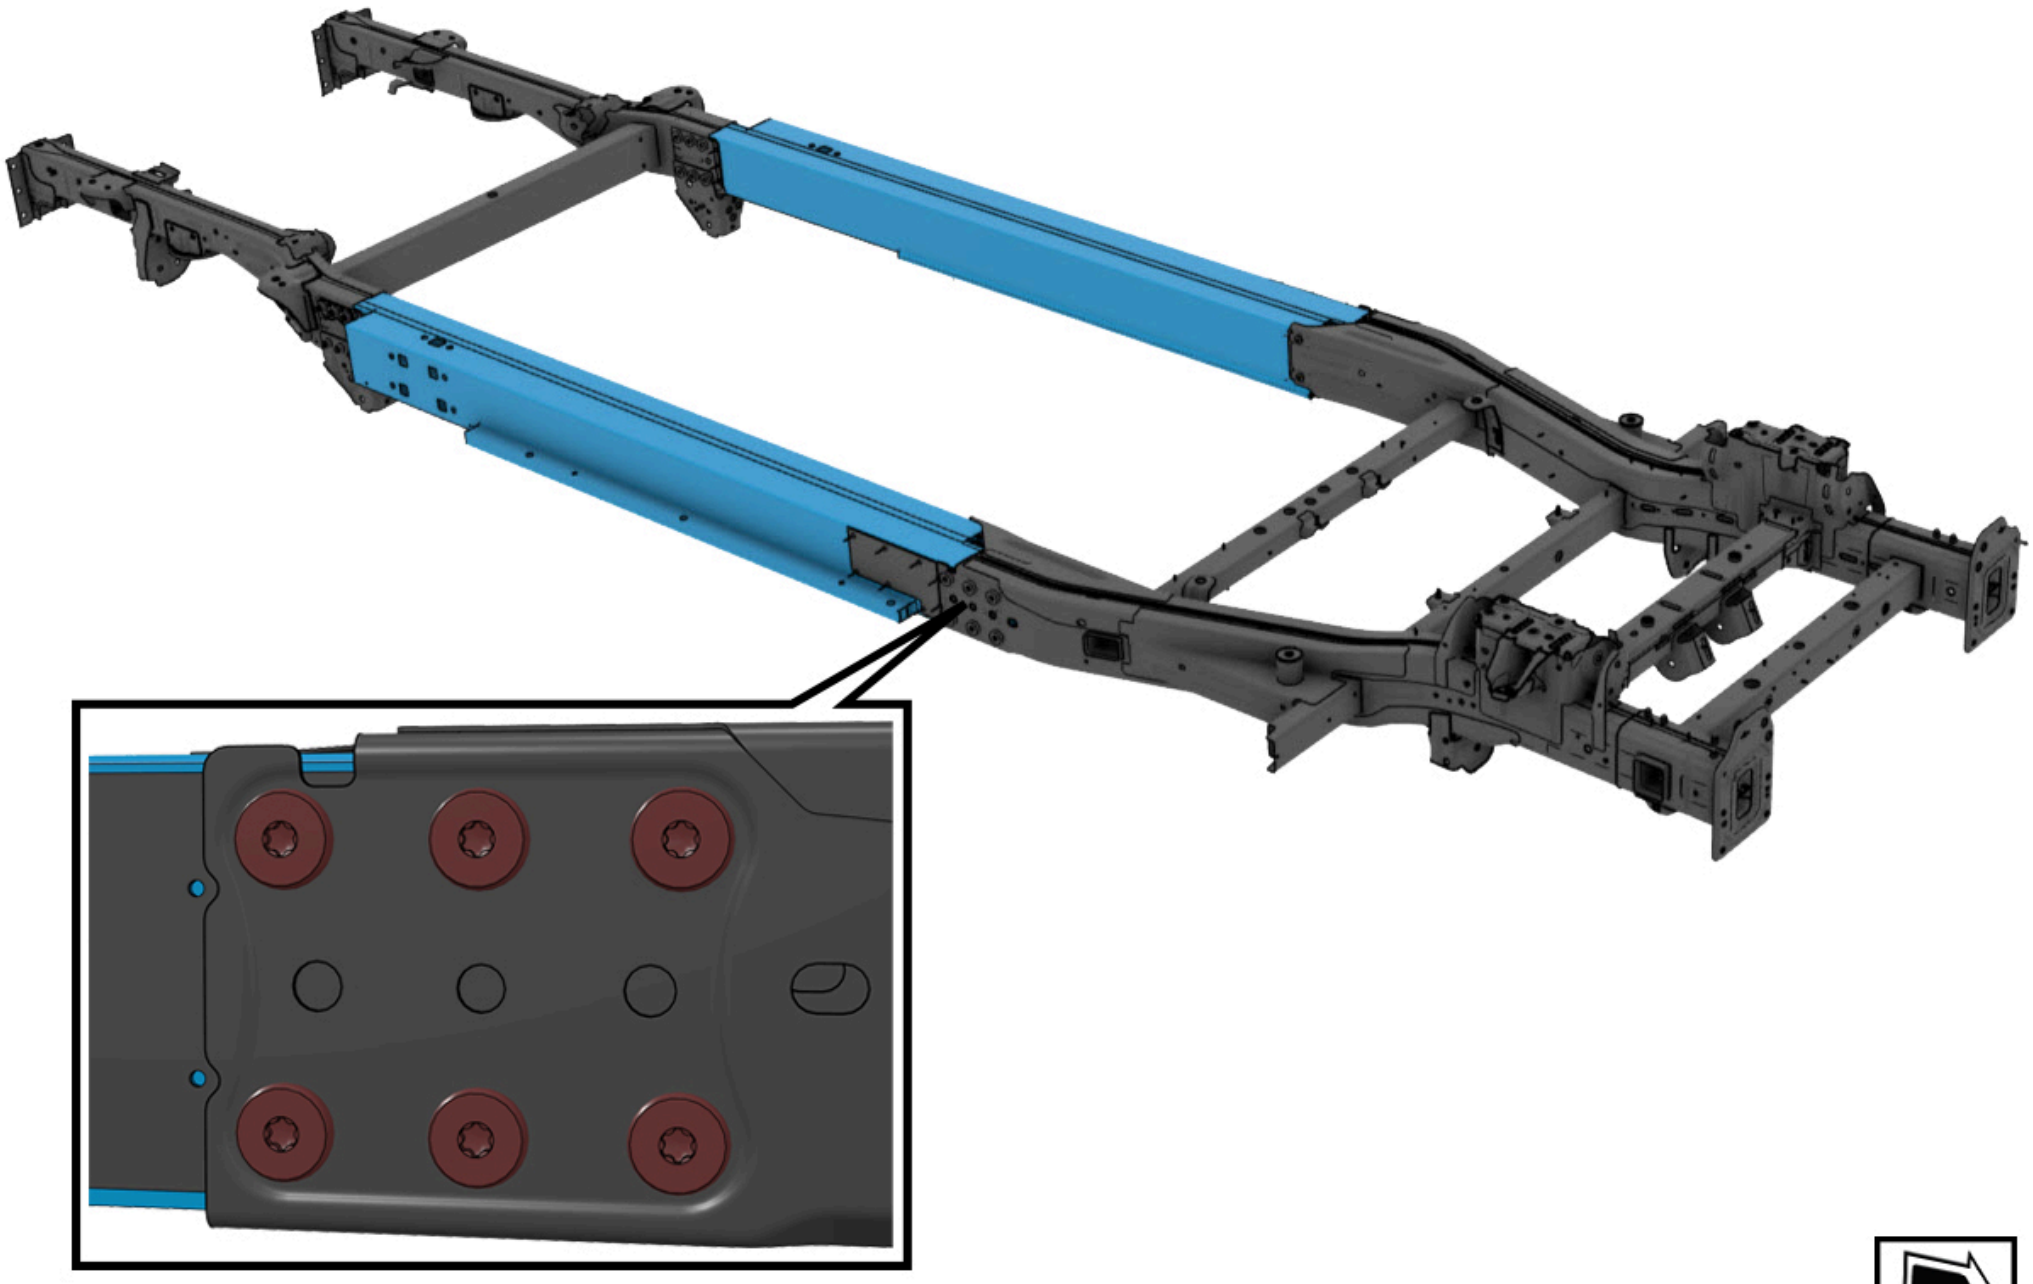
Frame Assembly Realignment - Bolted Connections

The EDV frame is composed of separate front and rear welded sub-assemblies joined together via bolted connections to two longitudinal structural members. In a front or rear impact, the bolted connections between the welded assemblies and the longitudinals may slip and result in the overall frame assembly measuring out of specification. If no material damage is observed at the bolted connections, and the welded assemblies themselves show no signs of damage, nor measure out of specification, loosen the bolted connections and realign the assemblies to bring the entire frame within specification.
