# RCI-30-25-001-1 High Voltage (HV) Battery Handling and Damage Inspection Guidelines

## Rivian Automotive, LLC - Service Guideline

Document Type	Collision Repair Information Document
Date	November 21, 2025
Affected Region(s)	North America, Europe
Affected Model(s)	R1T, R1S, EDV
Model Year(s)	2022+
Vehicle System	30 - High Voltage Battery

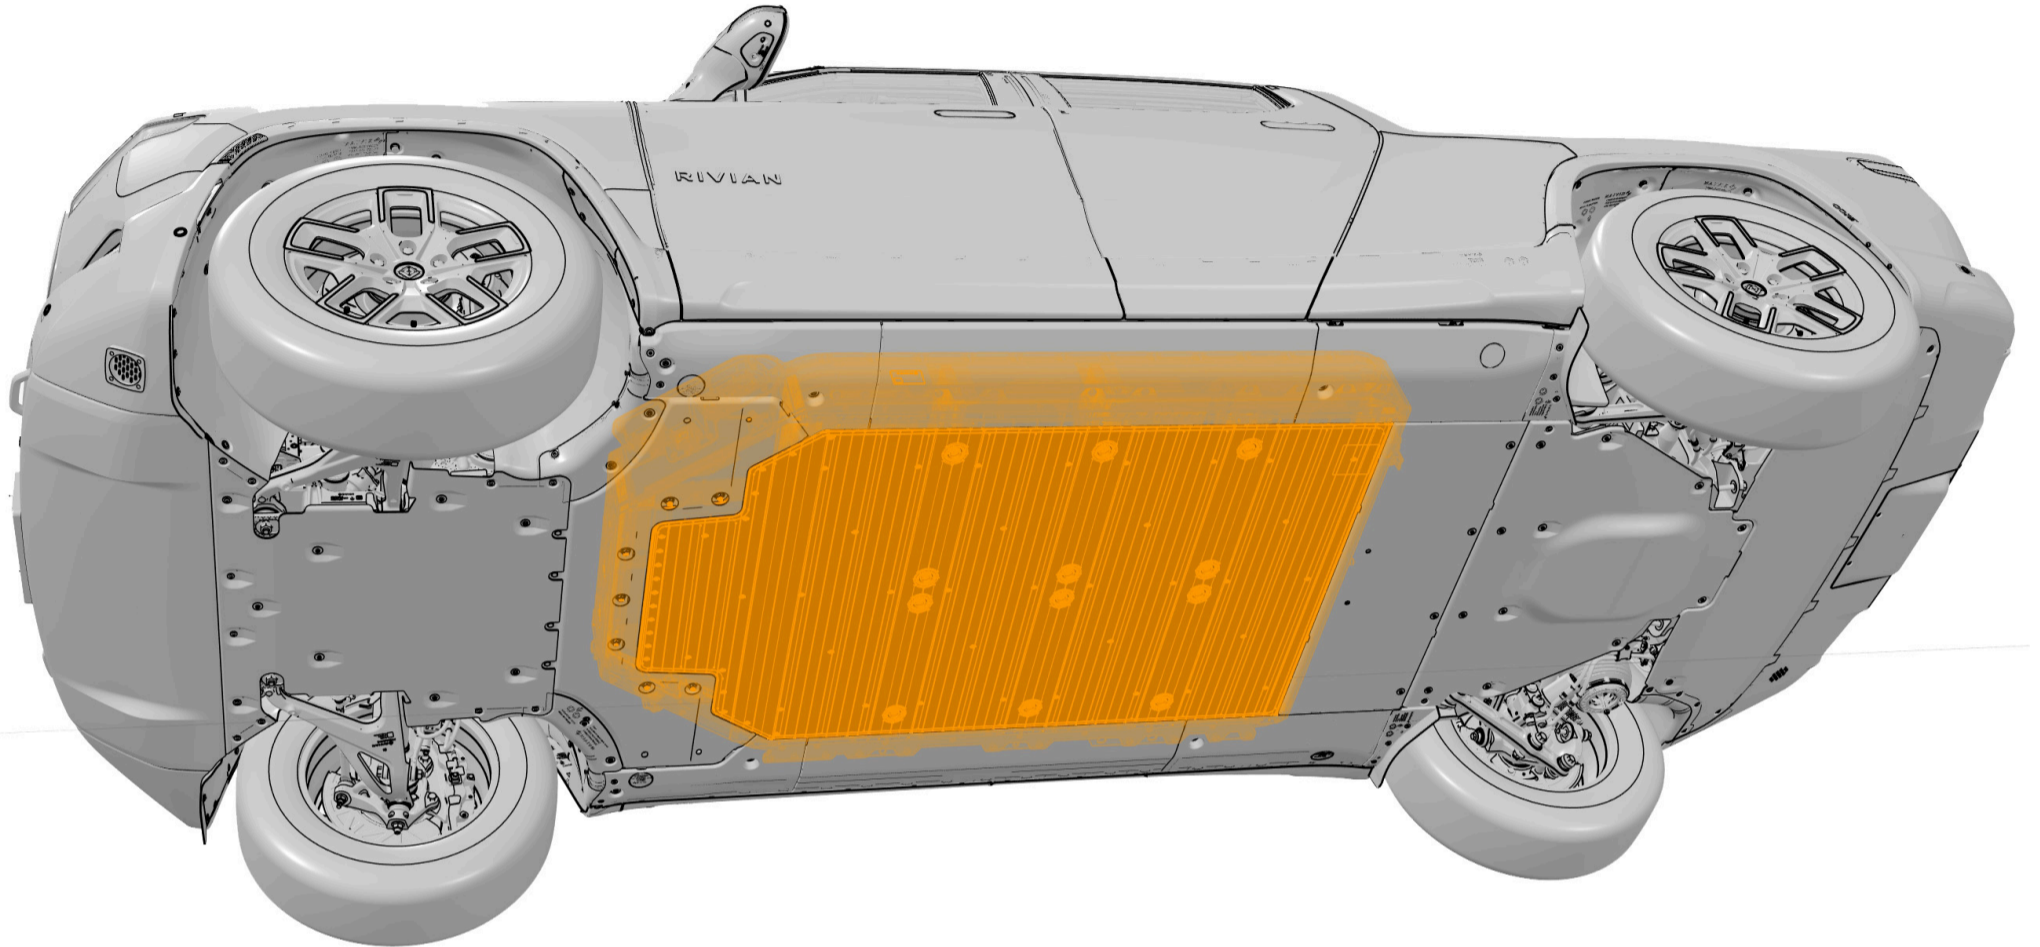
### Areas of Inspection

Inspection Point	Inspect For	Action
Battery housing	Sparks, smoke or flames	Call Emergency Services
	Electrical odors and fumes	
	Gurgling or bubbling noises	
	Any external leak(s) of battery cooling fluid (check coolant level)	Contact your regional Rivian Collision/Service Team to request more information or assistance with repair.
	Signs of moisture accumulation and possible corrosion	
	Any cracks, holes, or tears in the HV battery housing, or deformations that exceed the acceptable limits defined in the Non-Critical Damage section of this document.	
	Damaged non-serviceable HV Connectors	
	Damaged housing Seals	
	Evidence of electrical arc or thermal event such as welding or spatter marks, burn marks, or melted plastic or seals.

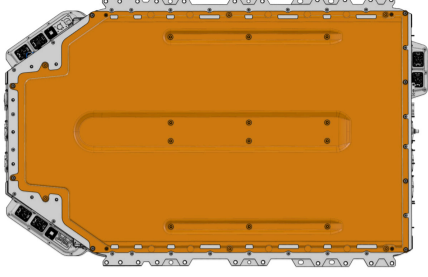
Model	Model Year	Variant/Battery Type	Figure
R1	2022-2024	On-Road

Some Rivian vehicles feature a replaceable skid plate mounted on the bottom of the HV battery pack to protect internal components from direct impact. If the skid plate is damaged, refer to the applicable service manual procedure for step-by-step replacement instructions.
