2014 MDX and 2017 Sport Hybrid Series: Model Body Repair Information

2014 MDX and 2017 Sport Hybrid Model Series

OVERVIEW OF BODY FEATURES

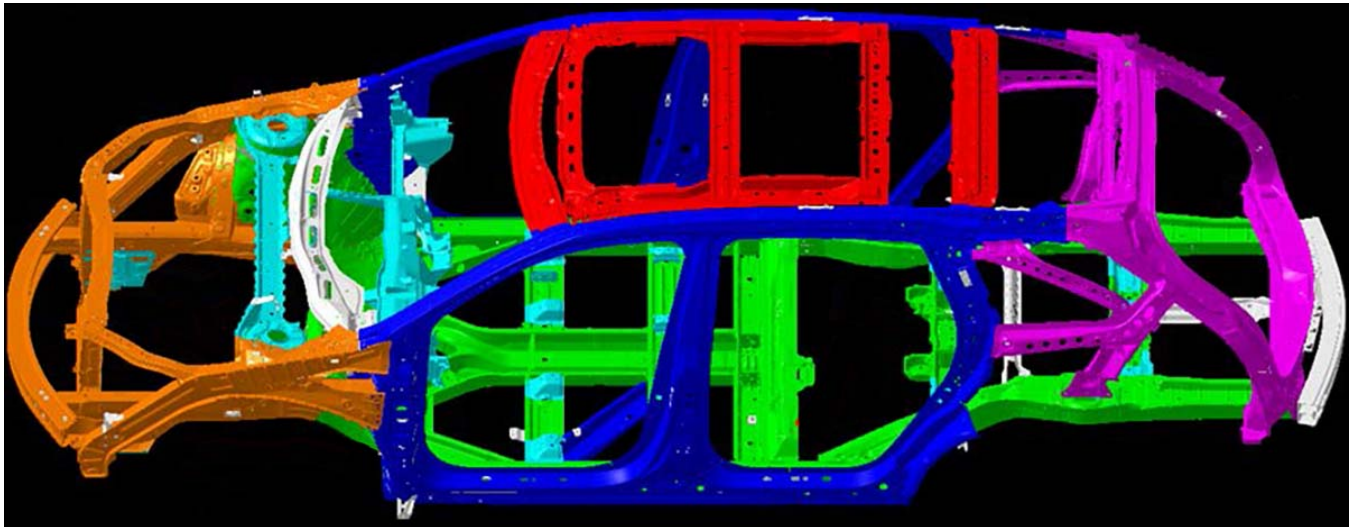
- Next-Generation Advanced Compatibility Engineering™ (ACE™) body structure.
- Rigid magnesium steering hanger beam mounts steering column and dashboard components.
- Reinforced cabin with 1,500 MPa one-piece front door outer stiffener rings.
- Reinforced roof structure.
- 3-Bone platform with additional stiffeners.
- Rigid tailgate opening ring with structural foam bulkheads applied at four locations.

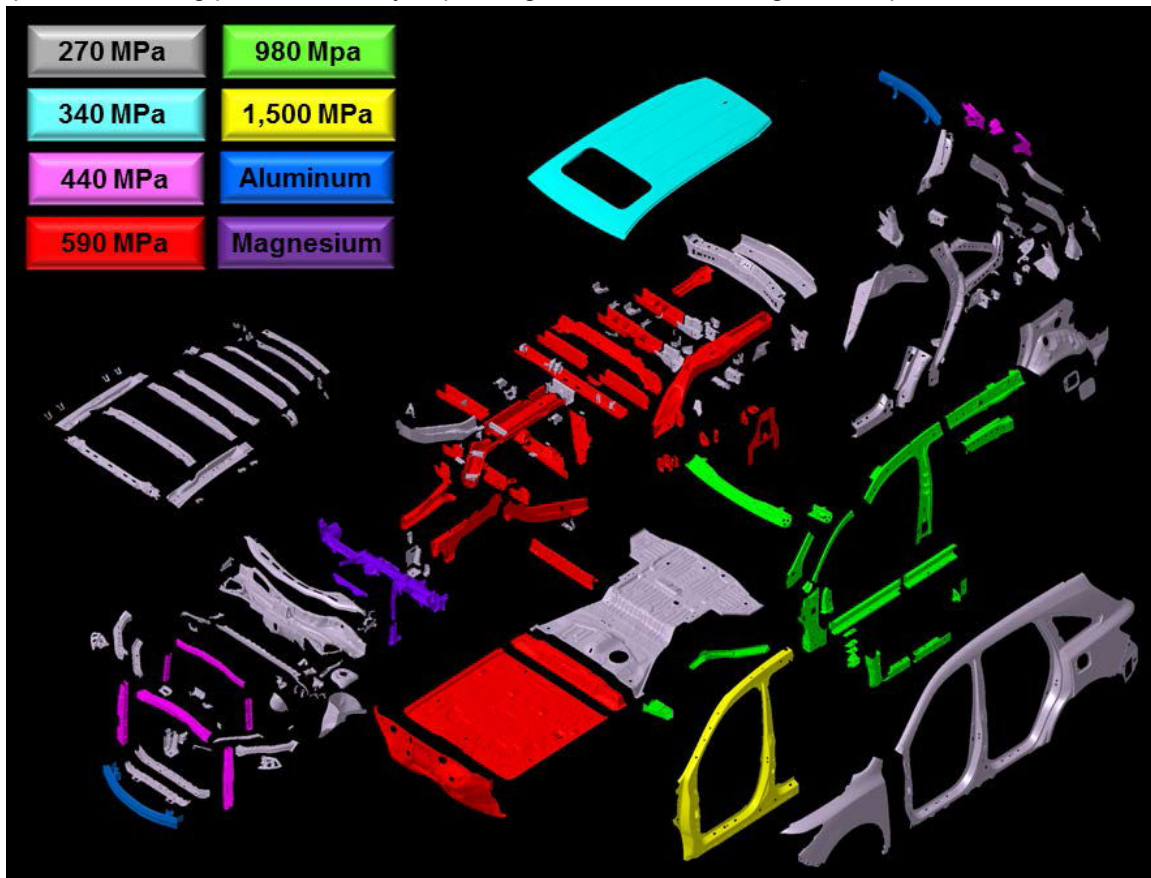
BODY CONSTRUCTION AND HIGH-STRENGTH STEEL CONTENT

- Steel parts are color-coded based on their tensile strength in megapascals (MPa).
- High strength steel (HSS) is defined as any steel with a tensile strength of 340 MPa or higher.
- Steel repair and welding procedures vary depending on the tensile strength of the parts involved.

These illustrations are for general reference only. Some body parts are constructed from multiple layers of different tensile strength steels. Always refer to the body repair manual body construction section for specific steel tensile strength information.

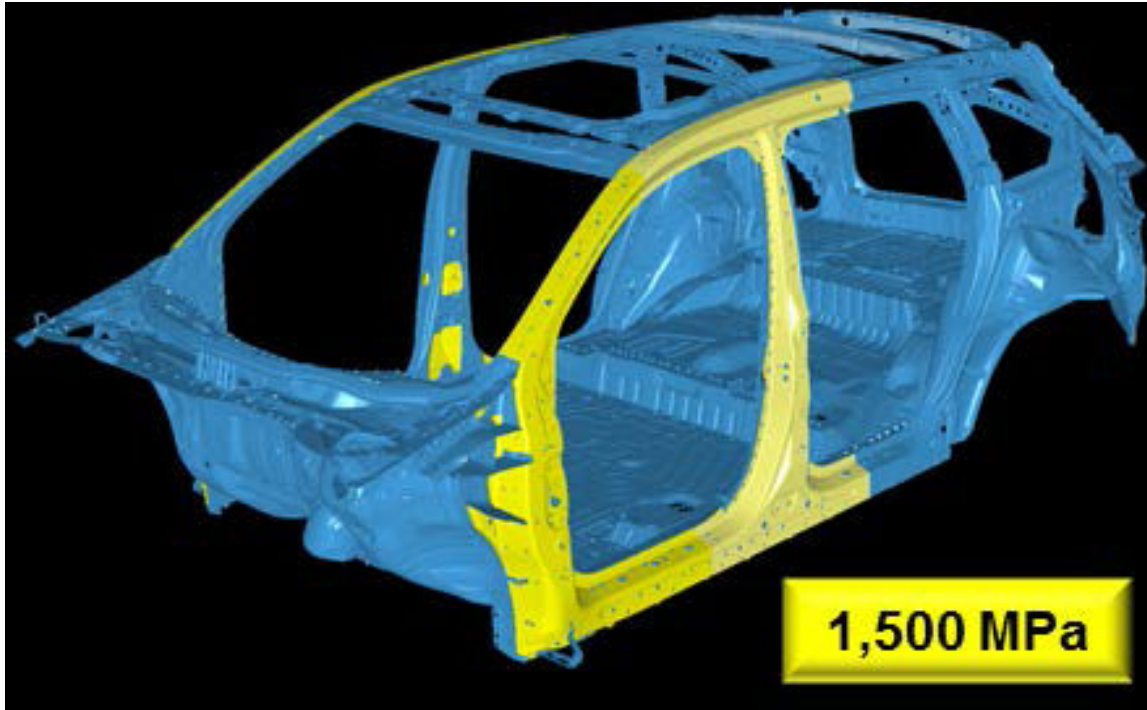
1,500 MPa (HOT STAMP) STEEL LOCATIONS

1,500 MPa steel is stronger than ordinary steel, so it can help protect vehicle occupants while reducing overall vehicle weight to improve fuel efficiency.

The one-piece front door outer stiffener rings and door reinforcement beams are made from **1,500 MPa** steel. This steel is stronger than ordinary steel, so it can help protect vehicle occupants while reducing overall vehicle weight to improve fuel efficiency.

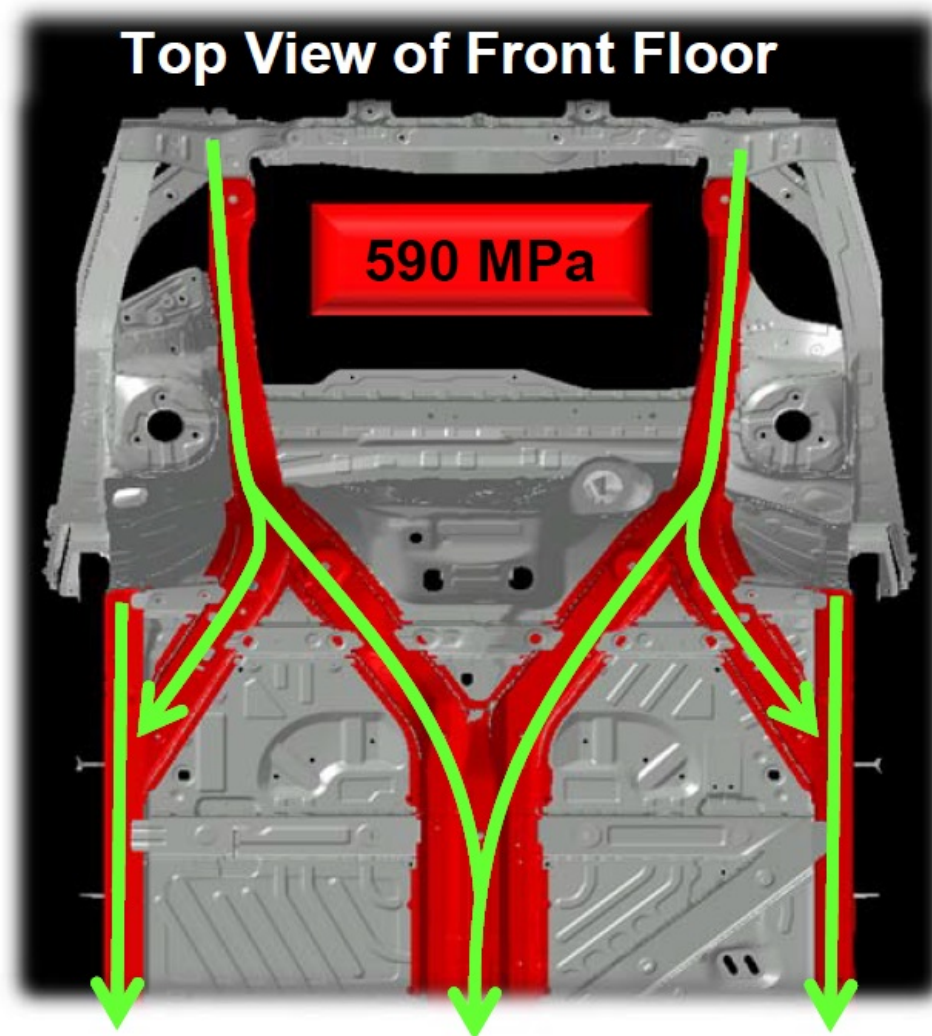
3-BONE PLATFORM STRUCTURE

A 3-Bone platform structure is used on this vehicle.

- The structure improves impact load management around the cabin while reducing weight.
- Additional floor reinforcements may require replacement or spot weld removal if damaged in a collision.
- Limited sectioning allowed to the front side frame and rear frame B parts. Refer to the body repair manual for complete information.

Green Arrows = Impact Load Paths

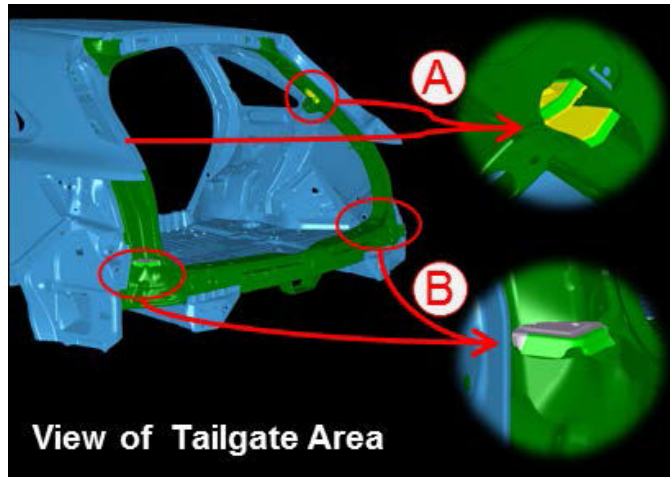
STRUCTURAL FOAM LOCATIONS AND REPAIR

Structural foam bulkheads are used to improve body stiffness at the left and right inner panel assembly (A) and inside the floor rear cross member assembly (B). Replacement part assemblies have the structural foam pre-installed.

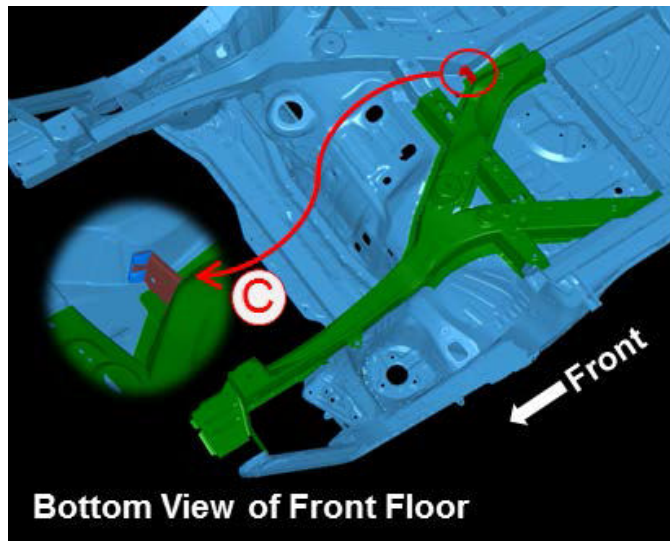
- A structural foam joint is used on a bracket that connects the left and right side center frames under the front floor (C). When replacing either the left or right front side frame assemblies, a special room-temperature cured 2-part epoxy structural adhesive (L&L Products L-0504, 3M 7333 Impact Resistant Structural Adhesive, or equivalent) is required to replicate this joint.
- Because of limited shelf life, the adhesive must be ordered at the same time as the replacement front side frame.
- Once the adhesive/foam is applied, the parts can be assembled and welded. The repair adhesive material will cure at room temperature in **24** hours.

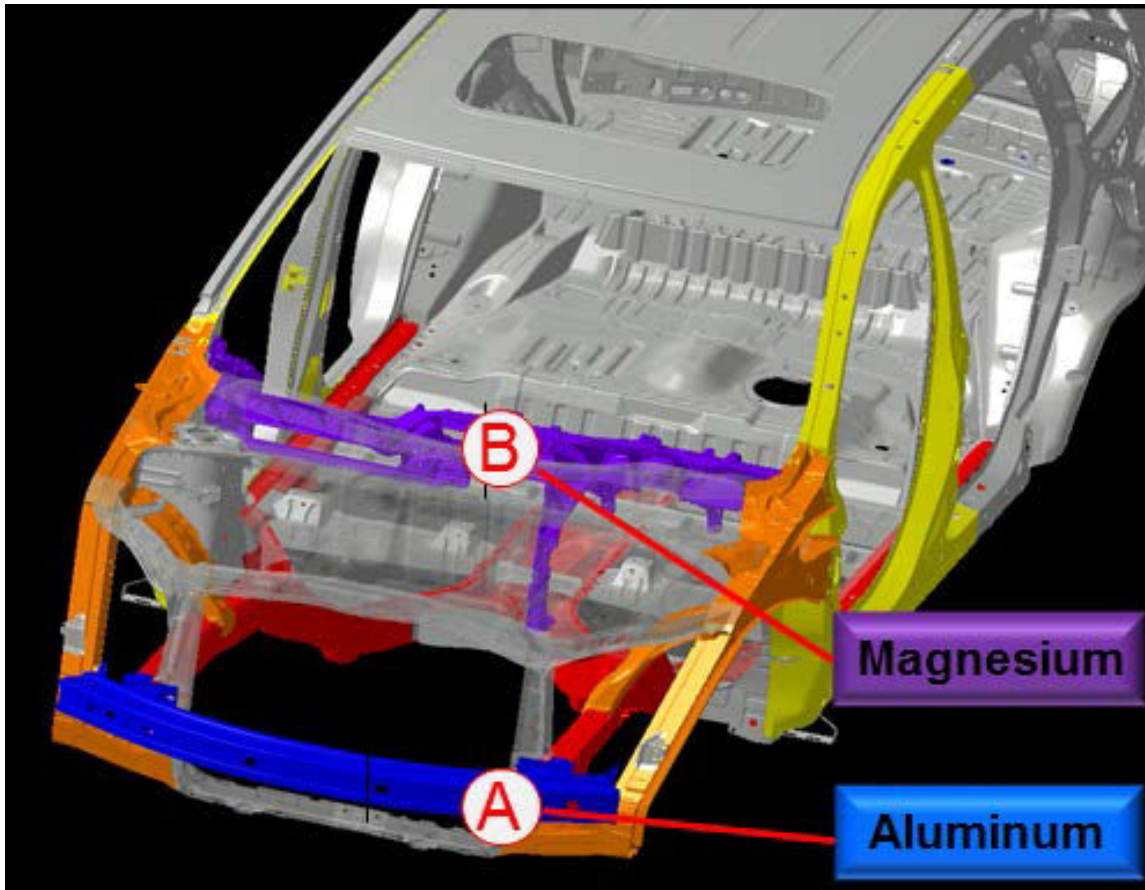
ALUMINUM AND MAGNESIUM PARTS

Aluminum alloy parts include these items:

- Hood panel
- Front and rear bumper reinforcement beams (A)

Magnesium alloy parts include:

- Steering hanger beam (B)

Do not attempt to repair magnesium parts and aluminum bumper reinforcement beams if damaged.

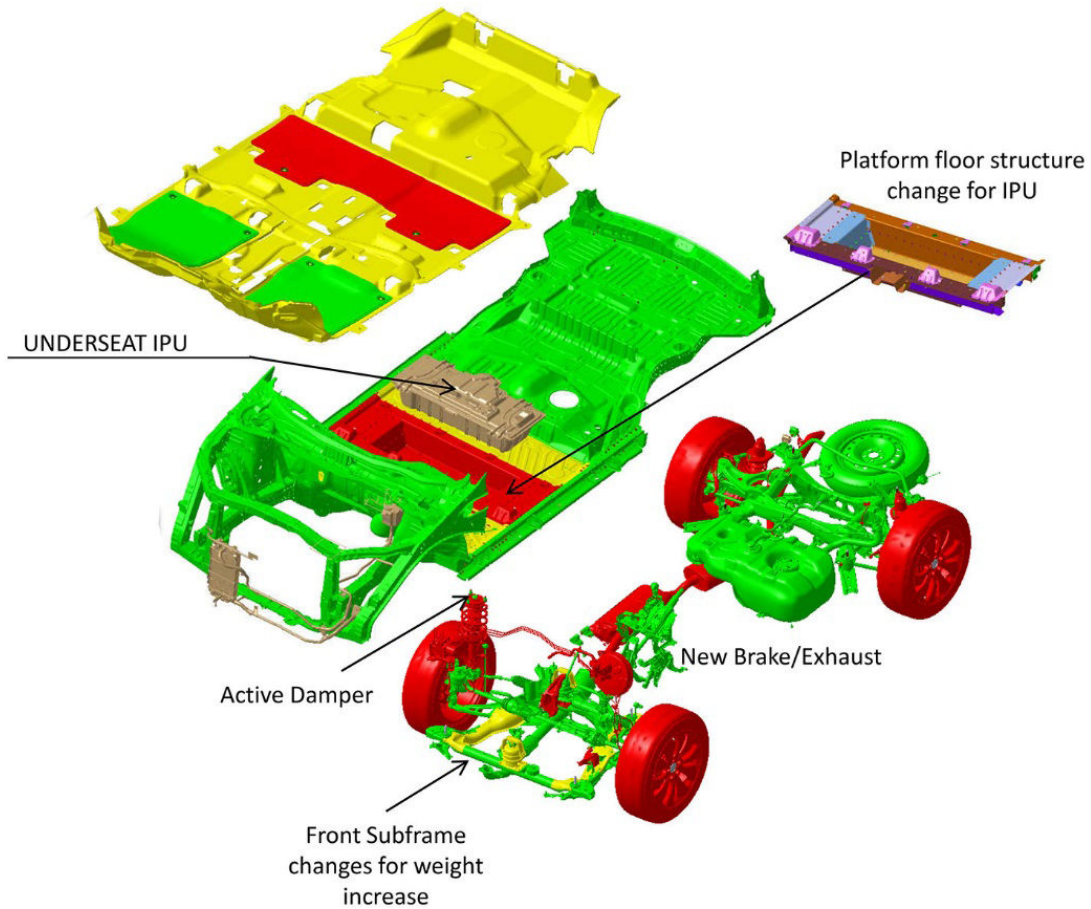
Frame Change Points

- Active damper
- New Brake/Exhaust
- Platform floor structure change for IPU (Intelligent Power Unit)
- Underseat IPU
