Body Repair News

2015 TLX: New Model Body Repair Information

2015 TLX Model Series

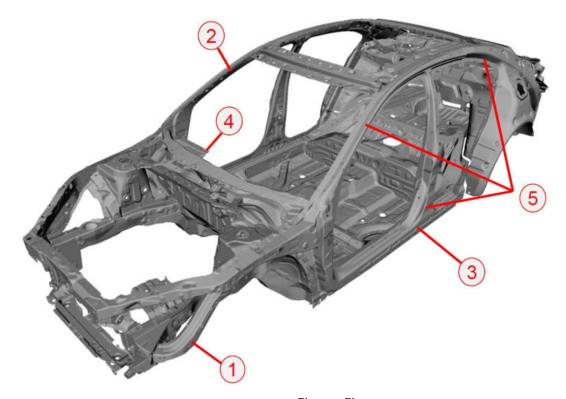
Next-Generation Advanced Compatibility Engineering[™] (ACE[™]) body structure.

- 1. Next-Generation Advanced Compatibility Engineering[™] (ACE[™]) body structure.
- 2. Body construction using 56% high tensile strength steel, including 10% in grades 780, 980, and 1,500 MPa.
- 3. Reinforced cabin with 1,500 MPa one-piece front door outer stiffener rings.
- 4. Rigid magnesium steering hanger beam mounts steering column and dashboard components.
- 5. First Acura use of NVH acoustic spray foam, replacing baked-in acoustic separators.

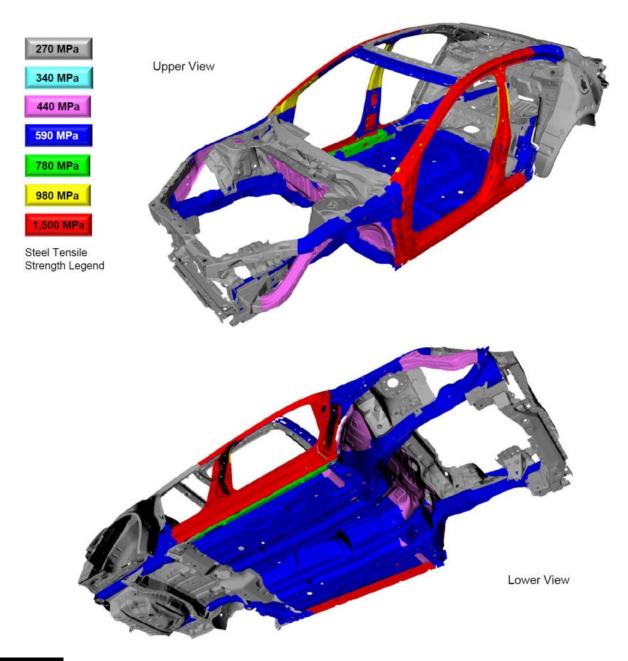
BODY CONSTRUCTION AND HIGH-STRENGTH STEEL CONTENT

- Steel parts are color-coded based on their tensile strength in megapascals (MPa).
- High strength steel (HSS) is defined as any steel with a tensile strength of 340 MPa or higher.
- Steel repair and welding procedures vary depending on the tensile strength of the parts involved.

These illustrations are for general reference only. Some body parts are constructed from multiple layers of different tensile strength steels. Always refer to the body repair manual body construction section for specific steel tensile strength information.

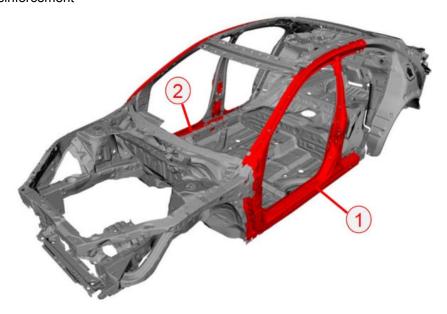
1,500 MPa (HOT STAMP) STEEL LOCATIONS

1,500 MPa steel is stronger than ordinary steel, so it can help protect vehicle occupants while reducing overall vehicle weight to improve fuel efficiency.

- 1. Outer Stiffener Ring* (includes):
 - Side Sill Center Stiffener**
 - Center Pillar Lower Reinforcement**
 - Center Pillar Reinforcement**
- 2. Inside Sill Reinforcement*

^{*} Constructed from 1,500 MPa steel.

^{**} Can only be serviced as part of the complete outer stiffener ring assembly (1).

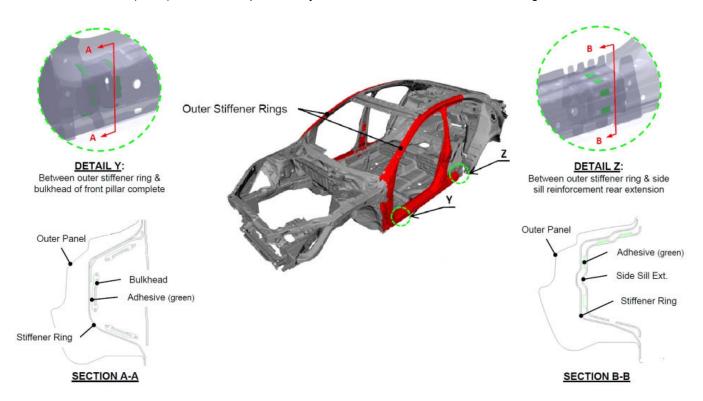
STRUCTURAL ADHESIVE LOCATIONS AND REPAIR

Structural adhesive (foam) is used to improve body stiffness under the outer stiffener ring as shown below.

When replacing the outer stiffener ring, a special room-temperature cured 2-part epoxy structural adhesive (L&L Products L-0504, <u>3M 7333 Impact Resistant Structural Adhesive</u> or equivalent) is required to replicate these joints.

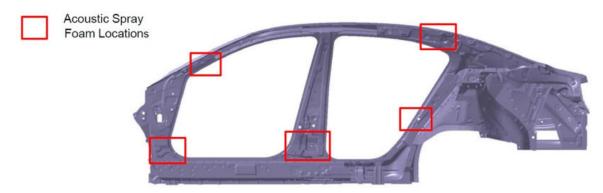
Foam Control Shelf Example

To improve body sealing and reduce NVH, acoustic spray foam is applied. This replaces the traditional baked-in acoustic separators. The foam is factory applied after paint and guickly cures at room temperature.

- Service procedure is the same as factory application. Refer to the Replacement section of the body repair manual.
- If foam replacement is required during body repairs, use a commercially available 2-part polyurethane foam, such as 3M AUTO MIX Flexible Foam 8463, or equivalent.
- Foam is applied through designated holes in the vehicle body structure.

Plastic foam control shelves installed inside body cavities control foam travel during application.

- Replacement shelves are part of the steel parts COMP, or available as separate service parts, depending on location.
- The minimum foam application amount for each location is provided in grams. To determine applied mass, weigh foam containers on a metric scale before and after application. The difference is the amount of foam applied.

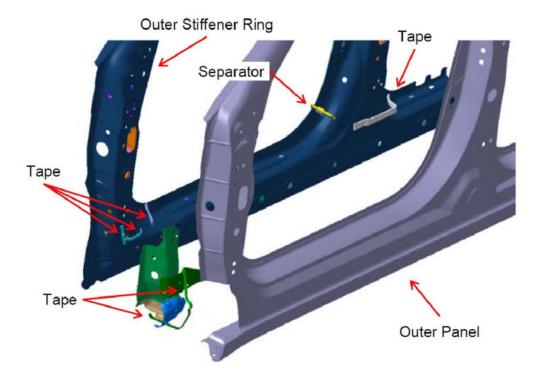
NVH SEALER TAPE AND SEPARATORS

To reduce NVH in areas where acoustic foam is not feasible, NVH sealer tape and separators are applied in certain locations between the outer body panel and outer stiffener ring as shown in the diagram below.

- The factory applied tape expands during the E-coat bake process.
- If sealer tape and/or separator replacement is required during body repairs, use a commercially available urethane body sealer.
- A specialized NVH damping material, such as 3M #04274, or equivalent, may also be used, if available.
