2023 HR-V Model Series: New Body Repair Information

2023 HR-V Model Series

OVERVIEW OF BODY FEATURES

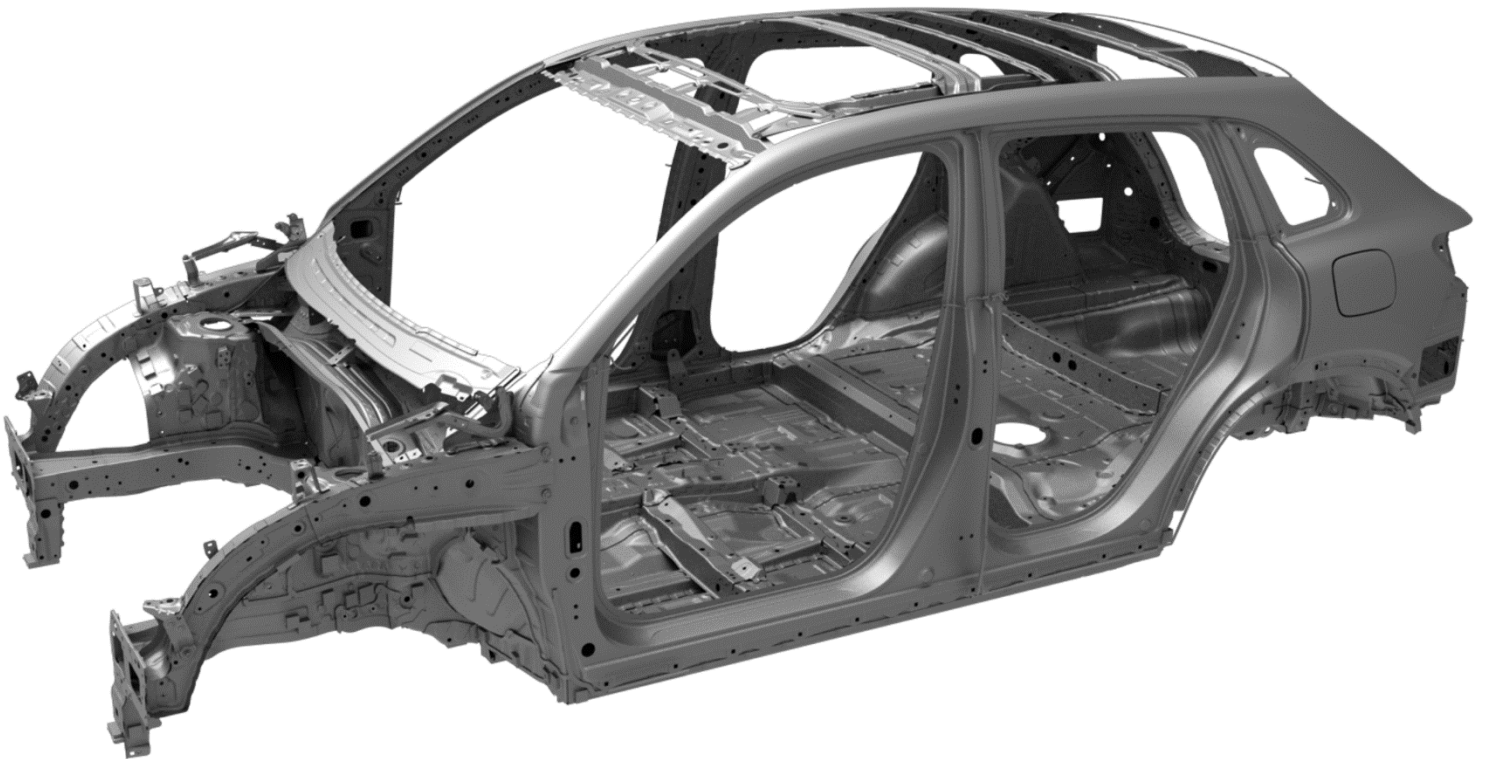
- Next-Generation Advanced Compatibility Engineering™ (ACE™) body structure.
- Body construction using high-strength steel (HSS) and advanced high-strength steel.
- Aluminum front and rear bumper beams for weight reduction and improved fuel economy.
- **1500 MPa** inner and outer door stiffener rings.

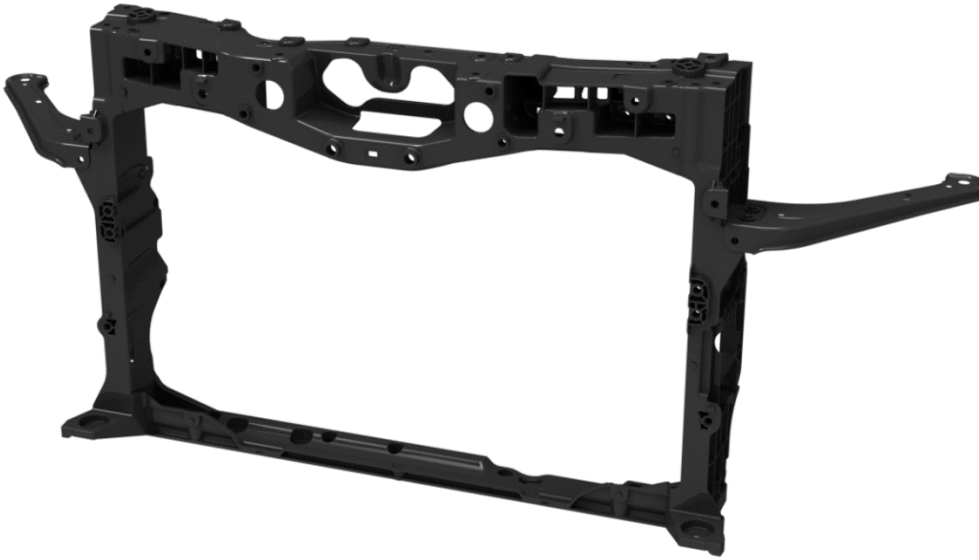
RESIN COMPOSITE FRONT BULKHEAD

This vehicle has a front bulkhead assembly constructed of resin composite material.

- The bulkhead design improves engine compartment access during factory assembly and service.
- The cooling fans, radiator, A/C condenser, hood lock, outside air temperature sensor, and related piping/components are attached to the front bulkhead.
- A damaged bulkhead must be replaced.
- For more details, refer to front bulkhead replacement in the body repair manual.

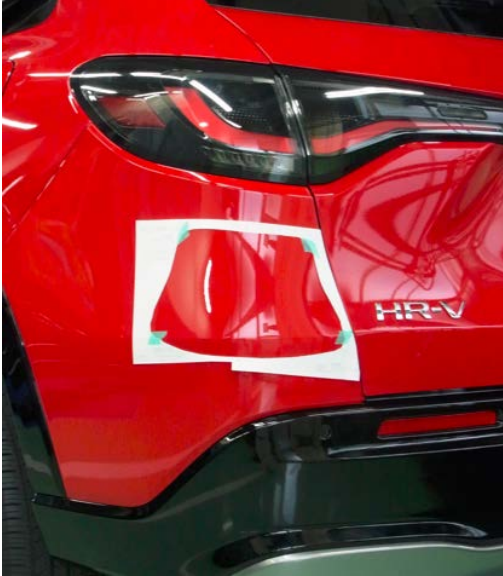
Blind spot Information (BSI) Rear Bumper Repair Templates

The 2023 HR-V model series Blind Spot Information radar units behind the rear bumper extend the detection range of previous systems but require extra consideration when repairing the rear bumper.

The radar waves passing through the rear bumper are more affected by the type and location of the repair. Cracks or dents within the radar wave emission range cannot be repaired and will require bumper replacement. Scratches inside or extending into the radar wave emission range will require the whole area to be painted and polished.

To assist technicians in determining where the radar wave emission area is, a printable template is provided in the body repair manual. This template can be taped onto the bumper and will help determine if the bumper can be repaired or will require replacement.
