## 2026 Passport Series: Body Repair Information

### INTRODUCTION

This publication contains a summary of new body and vehicle technologies that may affect collision and other body repairs. Always refer to the service information and body repair manual (BRM) for complete repair information. A subscription may be purchased at [Service Express](#).

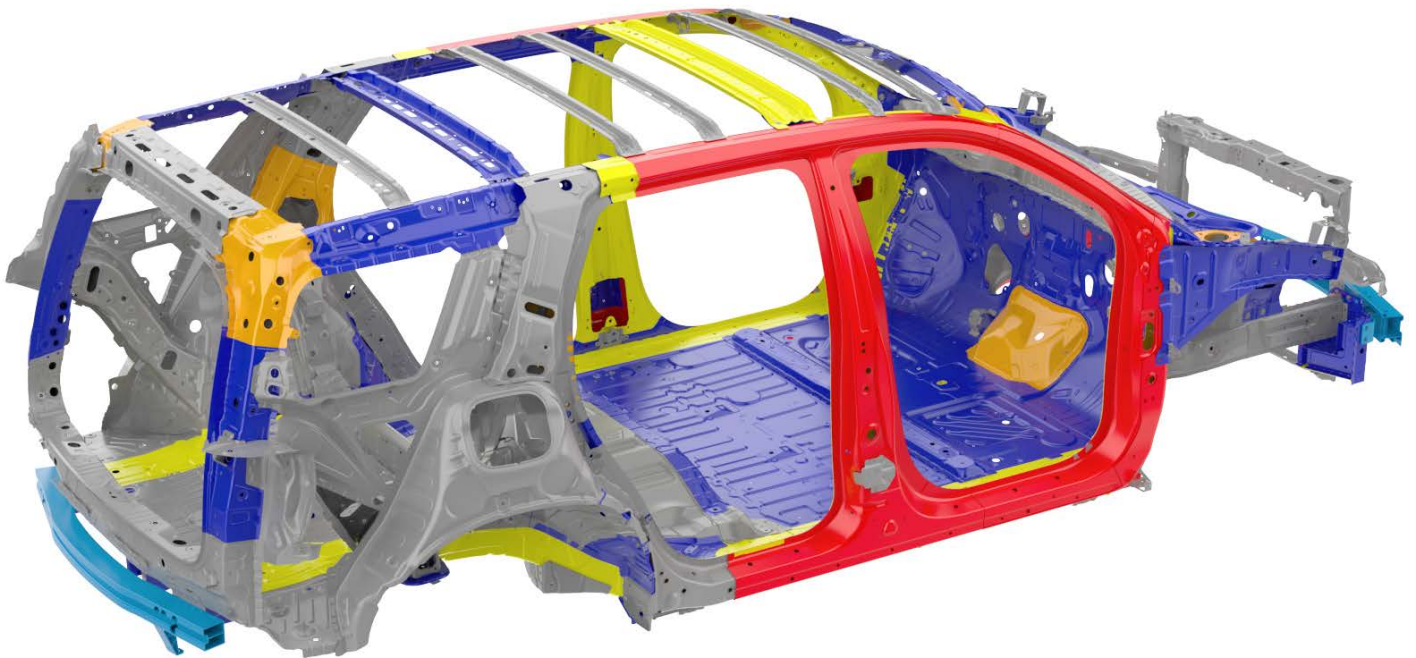
### BODY CONSTRUCTION AND HIGH STRENGTH STEEL CONTENT

- Steel parts are color coded based on their tensile strength in megapascals (MPa).
- High-strength steel (HSS) is defined as any steel with a tensile strength of **340 MPa** or higher.
- Ultra-high-strength steel (UHSS) is defined as any steel with a tensile strength of **980 MPa** or higher.
- Steel repair and welding procedures vary depending on the tensile strength of the parts involved.

NOTE: The illustrations on the next page are for general reference only. Some body parts are constructed from multiple layers of different tensile-strength steels. Always refer to the body construction section of the BRM for specific steel tensile-strength information.
