## 2023 Accord Model Series: New Body Repair Information

2023 Accord Model Series

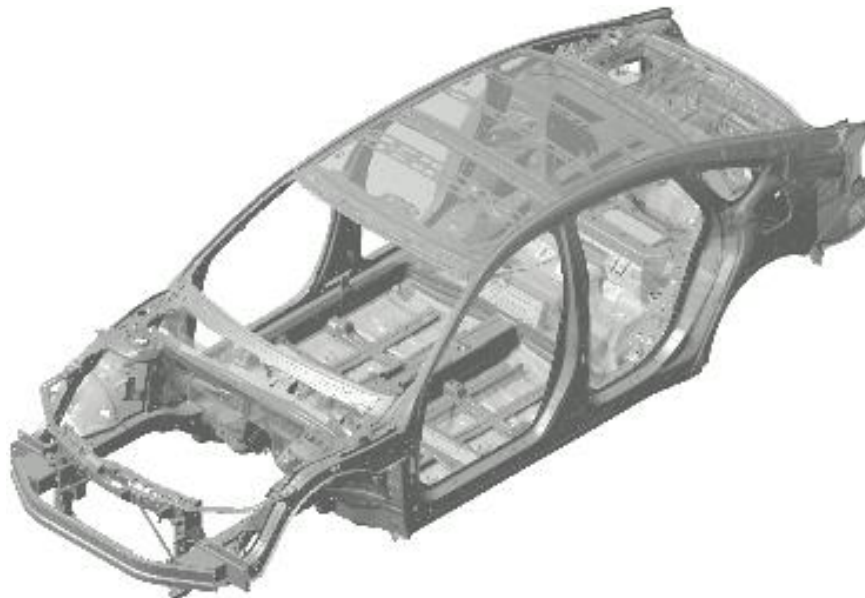
### OVERVIEW OF BODY FEATURES

- Lightweight, high rigidity body structure with outstanding safety.
- Body construction using high-strength steel (HSS) and advanced high-strength steel.
- Improved body against side impact and high rigidity by load path strengthening of rear circular bulk.
- Crush mode bending points created on left and right of the RR frame changed into crushing structure from prior 3-point bend mode.
- Strong lead paths created through larger cross-sections to protect against side impact and high rigidity.
- Design enhancement against side impact and high rigidity by dashboard and seat cross member's lateral relation improvement.
- Bulkhead material change from steel to resin creates a 4kg weight reduction.
- Rationalization of adhesive coating area throughout structure, realizes high rigidity balance.

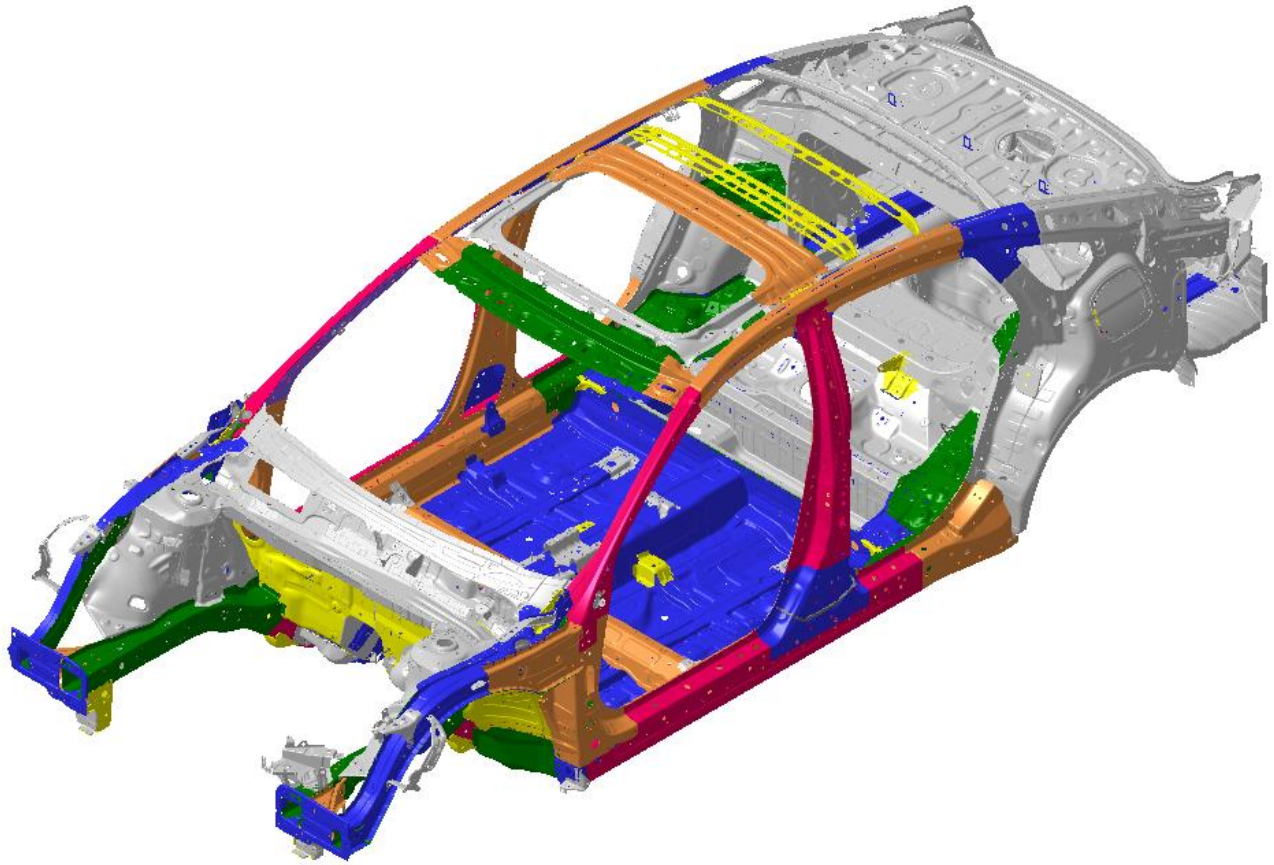
- The body of the Honda Accord Model Series is made of a combination of high-strength steel (HSS), advanced-high strength steel (AHSS), and ultra-high strength steel (UHSS) as indicated in the colored areas.
- Ultra-high-strength steel (UHSS) is defined as any steel with a tensile strength of **980 MPa** or higher.
- Steel repair and welding procedures vary depending on the tensile strength of the parts involved.
- Steel parts are color-coded based on their tensile strength in megapascals (MPa).

NOTE: Some body parts are constructed from multiple layers of different tensile strength steels. Always refer to the body construction section of the BRM for specific steel tensile strength information.

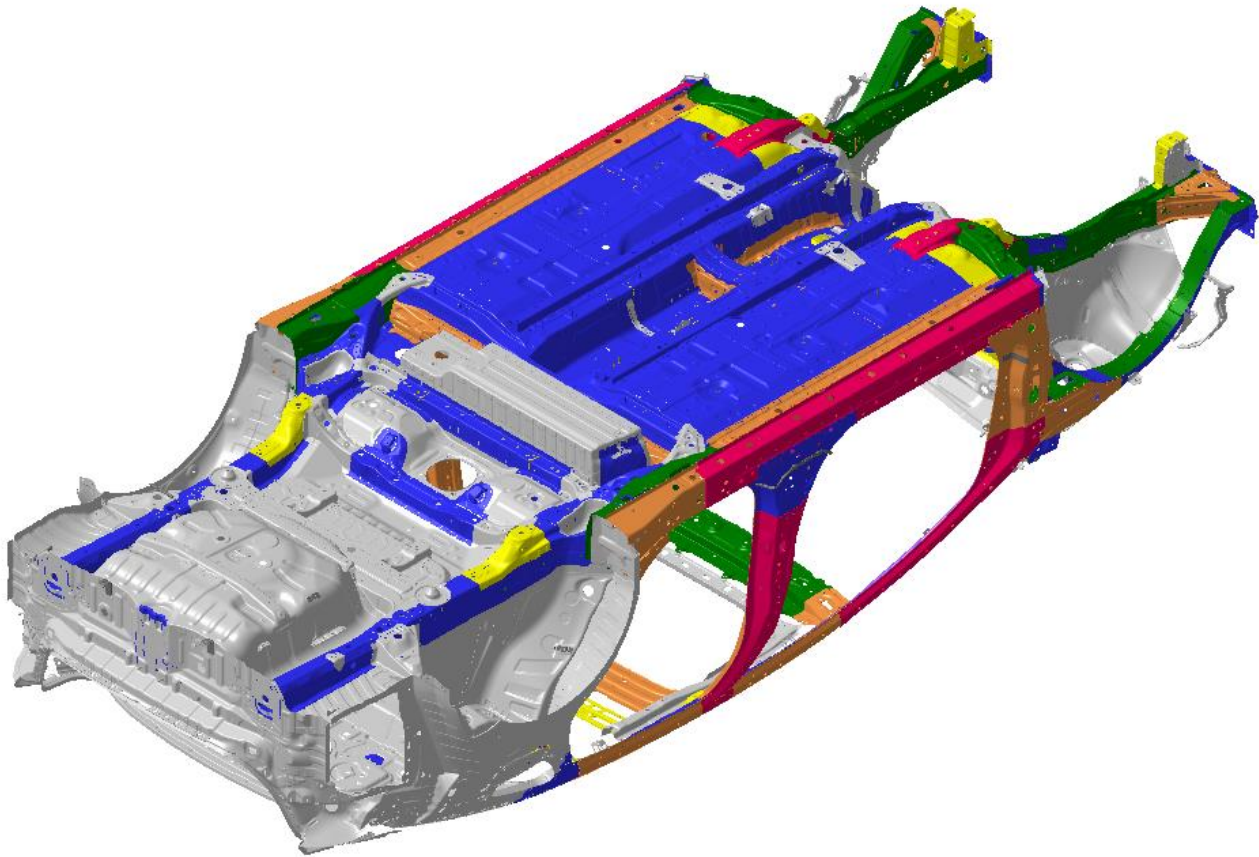
BODY CONSTRUCTION AND HIGH STRENGTH STEEL CONTENT (CONTINUED)

**1500**  
Mpa

**1180**  
Mpa

**980**  
Mpa

**780**  
Mpa

**590**  
Mpa

**440**  
Mpa

**340**  
Mpa

**270**  
Mpa

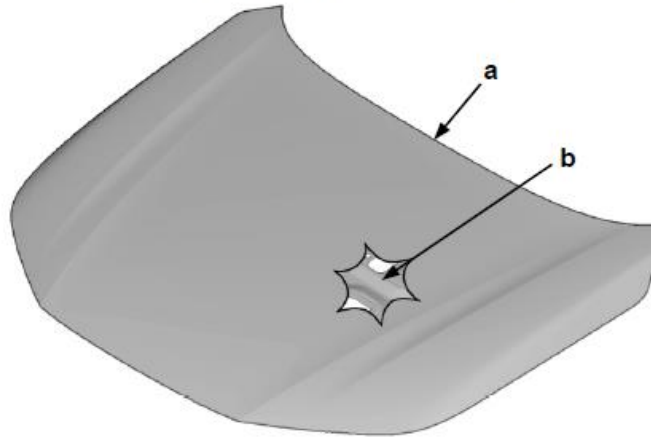
The hood of the 2023 Accord model uses aluminum alloy construction. Minor damage to the aluminum hood may be repaired by body shops that have dedicated aluminum repair facilities and tools.

- a: Hood Skin [1.0 (0.039)] Aluminum alloy
- b: Hood Frame [0.9 (0.035)] Aluminum alloy

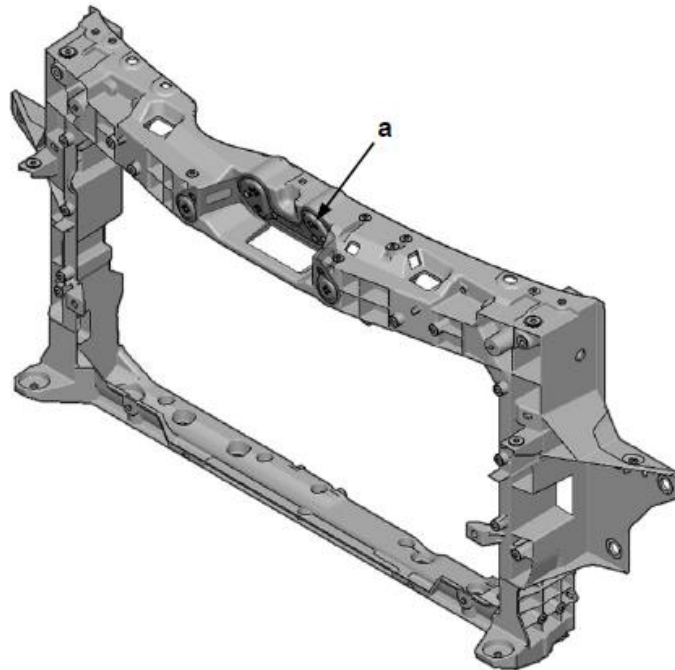
This vehicle has a front bulkhead assembly constructed of resin.

- Resin Material: PP
- a: Front Bulkhead Plate [1.0 (0.039)] 270, Zn

- The bulkhead material redesign results in a 4kg weight reduction.
- The intake, cooling fan, radiator, safety plate, hood lock, TM cooler pipe, and related piping/components are attached to the front bulkhead. Refer to the body repair manual for complete list and their specified torque limits.
- Be careful not to fasten parts on the bulkhead over the specified torque limits. Refer to the body repair manual for all specified torque limits.
- The entire bulkhead must be replaced when plastic parts around rivet nut or nuts are broken.
- A damaged bulkhead must be replaced.
- For more details, refer to front bulkhead replacement in the body repair manual.

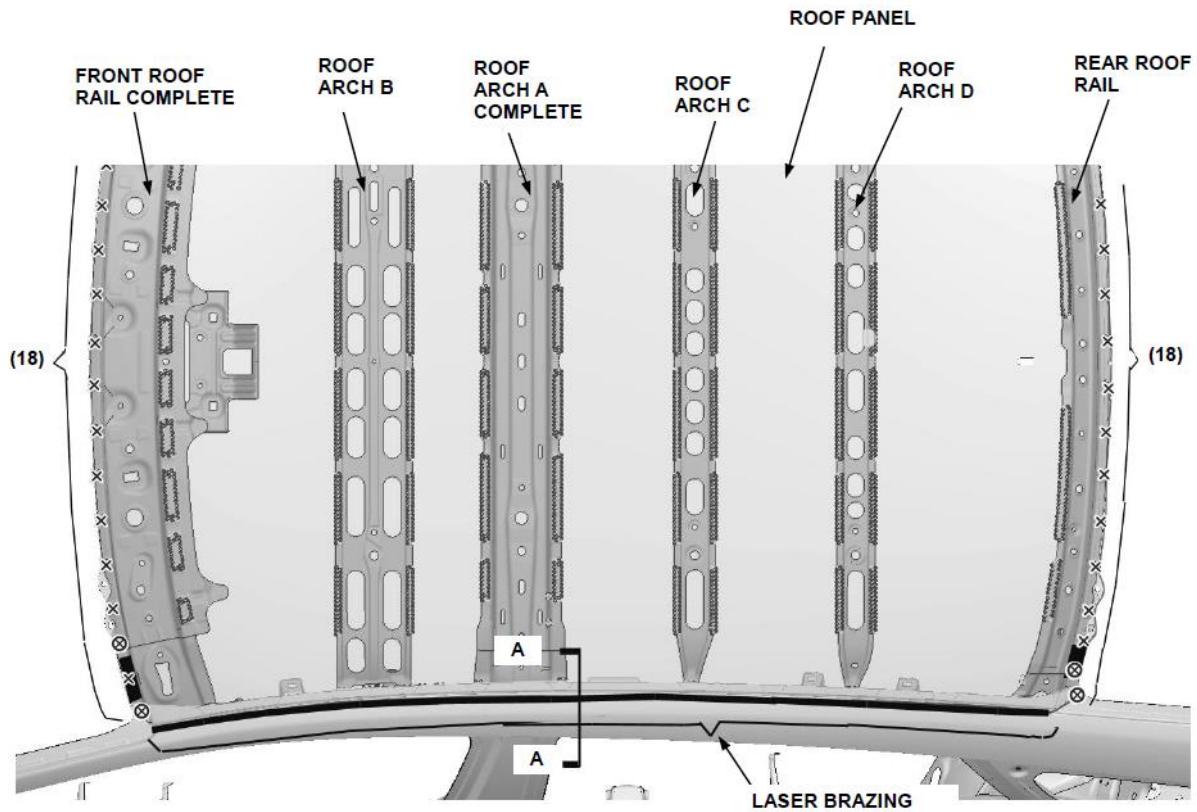
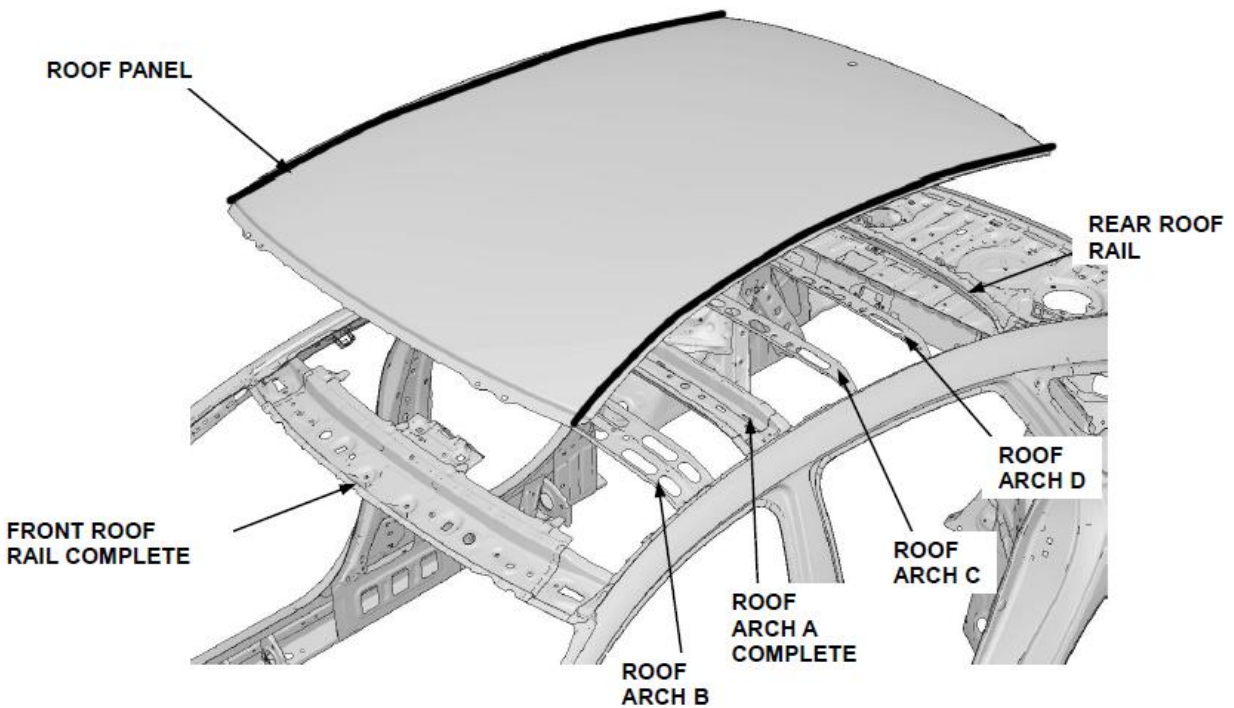
### Roof Panel (Without Moonroof)

Laser brazed roof panels require a combination of welding, and the use of adhesives and mechanical fasteners for replacement. Refer to the Roof Panel Replacement procedure for more details.

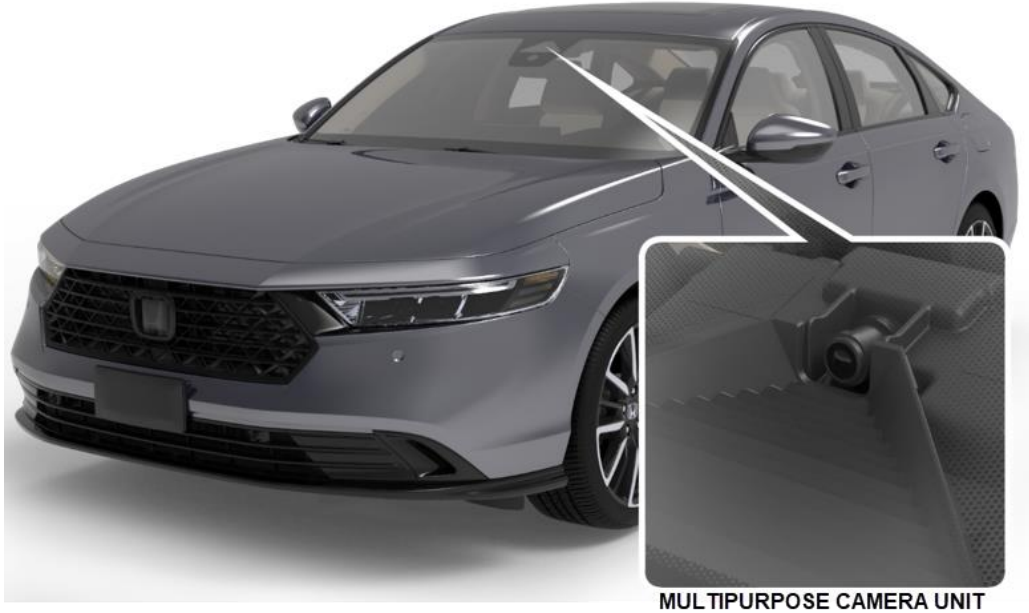
### Multipurpose Camera Aiming

The 2023 ACCORD model series is equipped with a multipurpose camera unit and millimeter wave radar. The multipurpose camera allows both dynamic and static aiming. Technicians now have the option to do either type of aiming depending on what their repair facility allows, or weather and traffic conditions.

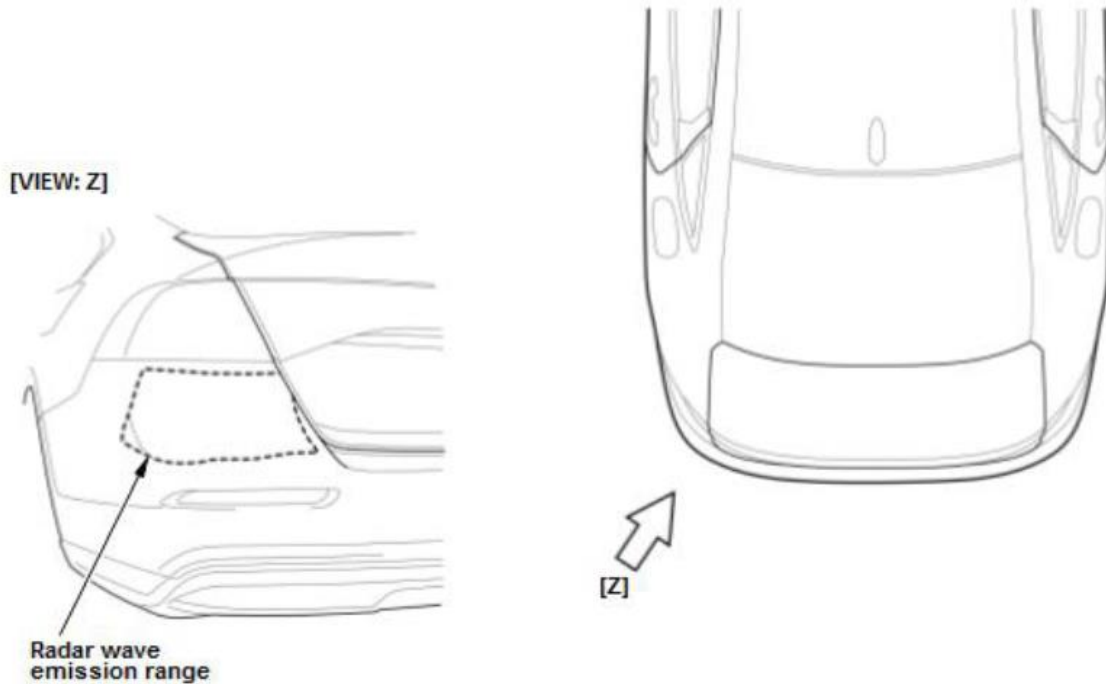
## Blind spot Information (BSI) Rear Bumper Repair Templates

The 2023 ACCORD model series Blind Spot Information radar units behind the rear bumper extend the detection range of previous systems but require extra consideration when repairing the rear bumper.

The radar waves passing through the rear bumper are more affected by the type and location of the repair. Cracks or dents within the radar wave emission range cannot be repaired and will require bumper replacement. Scratches inside or extending into the radar wave emission range will require the whole area to be painted and polished.

To assist technicians in determining where the radar wave emission area is, a printable template is provided in the body repair manual. This template can be taped onto the bumper and will help determine if the bumper can be repaired or will require replacement.

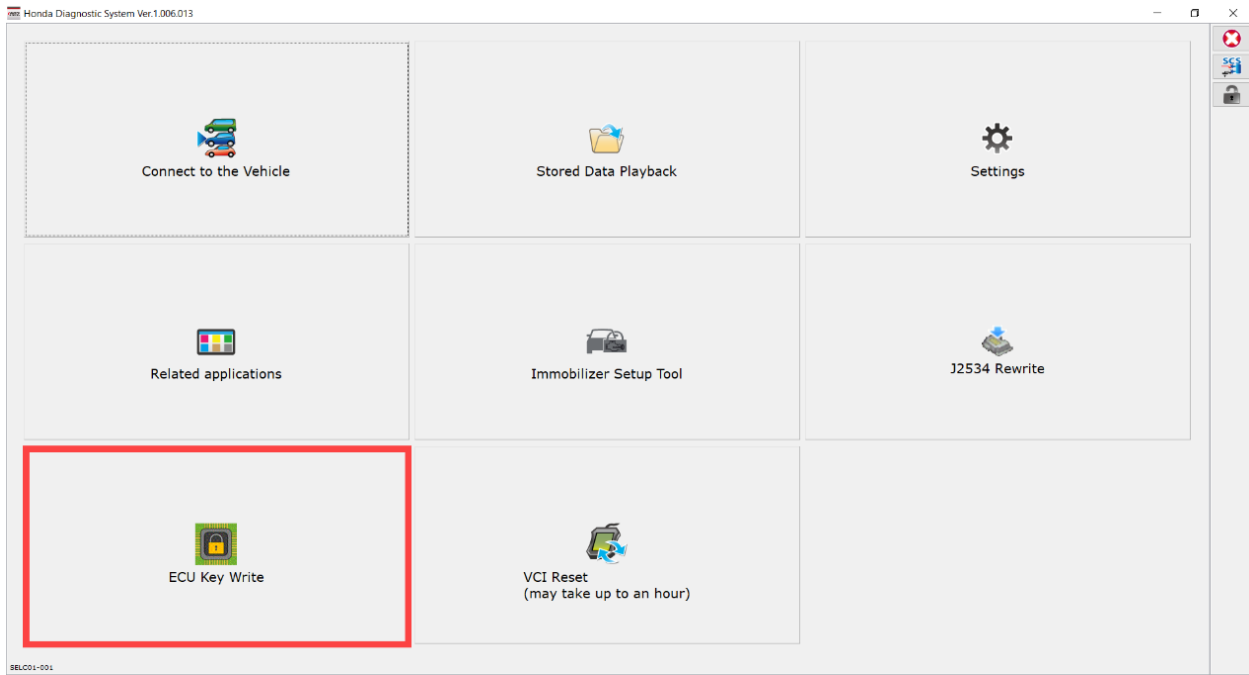
A security key code protocol is being introduced for certain electronic control units (ECUs). This protocol provides secured communication between control units, helping to prevent cyberattacks from outside sources.

When replacing control units like the VSA modulator control unit, you will need to access the **ECU Key Write** application in the i-HDS. For more information, refer to the job aid, *Using the ECU Key Write Application in the i-HDS*.
