## Collision Service Bulletin

### Aluminum Body Panel Corrosion Repair

<b>REFERENCE:</b>	<b>TSB:</b> 31-001-24 <b>GROUP:</b> 31 - Collision Bulletins	<b>Date:</b>	July 24, 2024	<b>REVISION:</b>	31-001-23 REV. A
<b>VEHICLES AFFECTED:</b>	2020 - <b>**2024**</b> (JT) Jeep Gladiator 2019 - <b>**2024**</b> (BV) Jeep Renegade 2015 - 2020 (4C) Alfa Romeo 4C 2017 - 2020 (BA) FIAT 124 Spider (Convertible) 2013 - 2019 (FF) FIAT 500 2017 - <b>**2024**</b> (GA) Alfa Romeo Giulia 2018 - <b>**2025**</b> (GU) Alfa Romeo Stelvio 2014 - 2023 (KL) Jeep Cherokee 2013 - <b>**2018**</b> (PF) Dodge Dart 2013 - <b>**2018**</b> (ZD) Dodge Viper 2013 - <b>**2022**</b> (DS) RAM 1500 Pickup 2013 - 2022 (WK) Jeep Grand Cherokee 2013 - <b>**2022**</b> (WD) Dodge Durango 2017 - <b>**2024**</b> (RU) Chrysler Pacifica 2015 - 2018 (BU) Jeep Renegade 2018 - <b>**2024**</b> (JL) Jeep Wrangler 2015 - <b>**2021**</b> (LA) Dodge Challenger 2013 - 2014 (LC) Dodge Challenger 2013 - 2023 (LX) Chrysler 300 2017 - <b>**2024**</b> (MP) Jeep Compass 2015 - 2017 (UF) Chrysler 200 2019 - <b>**2024**</b> (D2, DD, DF, DJ and DP) RAM Heavy Duty Trucks			<b>MARKET APPLICABILITY:</b>	<input type="checkbox"/> NA <input type="checkb

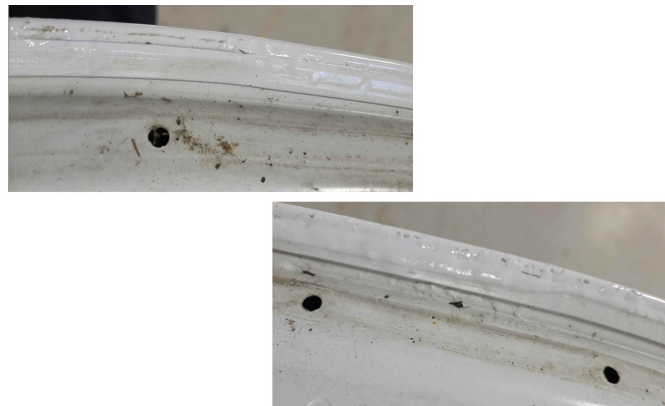
**Fig. 1**  
**Hem Flange Area Example**

**NOTE:** This bulletin does not apply to corrosion in the hem flange area; this will require panel replacement [Fig. 1](#).

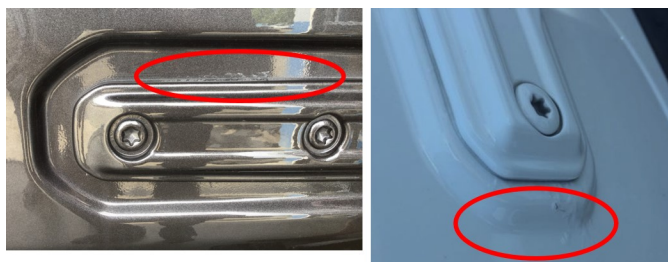
**Fig. 2**

Aluminum corrosion or bubbling on the doors and/or hinges [Fig. 2](#).

Examples Of Bubbling

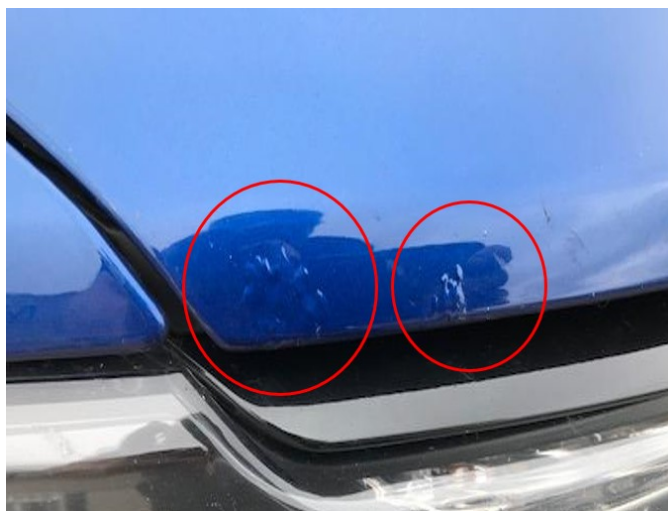
**Fig. 3**

Aluminum corrosion along the leading edge of hood or other exterior surface areas of the doors, fenders or liftgates [Fig. 2](#) or [Fig. 3](#).

Examples Of Corrosion Along Leading Edges

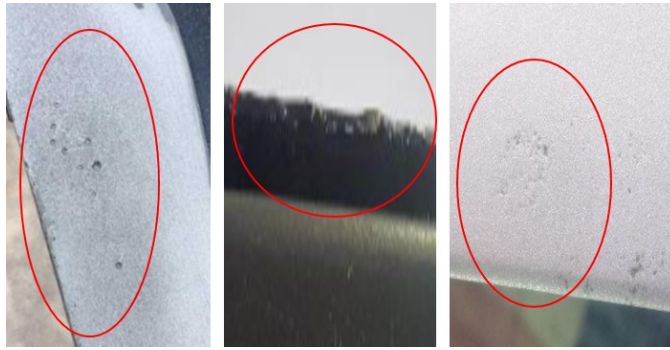
**Fig. 4**  
Corrosion Examples

2. After digital imaging or Regional Office approval and removing the initial blistered paint from the panel surface with 80 grit grinding disc, is severe pitting exhibited that cannot be removed with sandpaper, 3M Clean and Strip Disc or equivalent [Fig. 4](#)?

- YES>>> Replace the panel.
- NO>>> Proceed to [Step 1](#) of the repair procedure.
