On Target

For Ford and Lincoln wholesalers and the collision repair industry

2021 Ford Mustang Mach-E SUV: Vehicle-Specific Body Construction

2020–Current Lincoln Aviator / Ford Explorer: Front Subframe

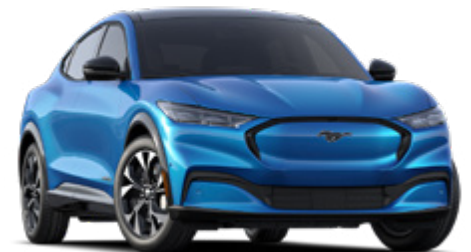
The body of the 2021 Mustang Mach-E SUV consists of the following:

- Front frame rails constructed of high-strength dual-phase (DP) 600 steel
- Rear frame rails constructed of boron ultra-high-strength steel
- Fender apron assembly constructed of dual-phase (DP) 600 high-strength steel
- Liftgate outer panel constructed of mild steel
- Body structure constructed of boron, dual-phase (DP) and high-strength steels
- Roof panel reinforcements constructed of dual-phase (DP) 600, smart and high-strength, low-alloy (HSLA) 380 steel

- Bolted, removable front fenders, hinged doors and hood
- Body-side outer panels constructed of mild steel
- Mastic pads used on floor pan for sound deadening

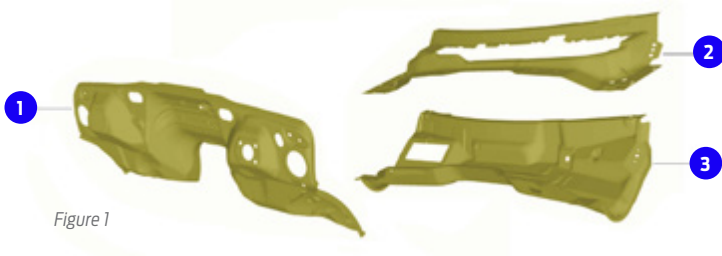
Figure 1

Cowl Panel and Dash Panel (Figure 1)

Item	Description	Steel Type
1	Upper cowl panel	Mild steel
2	Cowl panel assembly	Mild steel
3	Dash panel Assembly	Mild steel

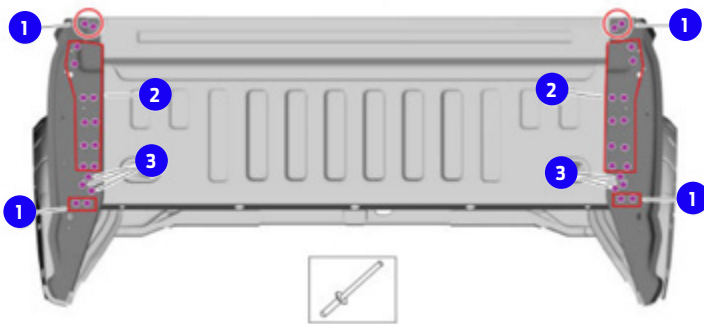
Figure 1

1. Using 80–120-grit sandpaper, sand to remove the e-coat and clean the outer edges of the front panel on both sides and the inner edges of the front panel extensions. Apply metal bonding adhesive to the outer edges of the front panel (on both sides) and install, properly position and clamp the front panel extensions, using locking pliers.

2. Using a 6.5 mm drill bit, drill guide holes and then install the necessary blind rivets:

1. W702512-S900C
2. W707638-S900C
3. W708777-S900C

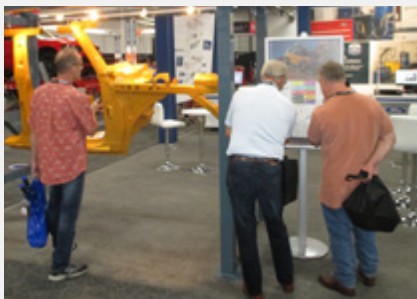
Attendees of the 2021 NORTHEAST Show—held in mid-September this year—inspect the new Ford Bronco display, which highlights the vehicle-specific body components and their compositional makeup.
