# RCI-52-22-007-4: Model Year 2022-2024 Vehicles R1T Material Matrix and Repair Guide

## Rivian Automotive, LLC Service Document

| <b>Vehicle System</b> | 52 - Body |

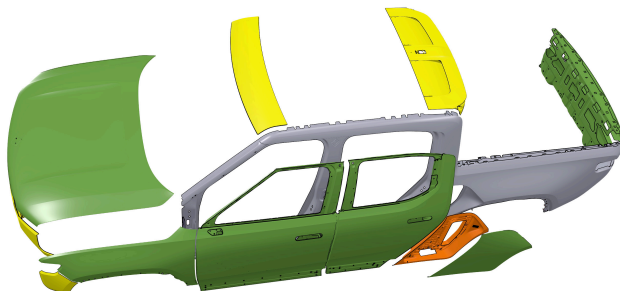
**Closures & Exterior Trim**

| Color Key | Material Type |
| | Conventional Steel |
| | Aluminum Sheet |
| | Magnesium |
| | Plastic |
