# RCI-52-24-002-1: Model Year 2025+ Vehicles R1T Material Matrix and Repair Guide

## Rivian Automotive, LLC Service Document

| <b>Document Type</b> | Collision Repair Information Document |
| <b>Vehicle System</b> | 52 - Body |

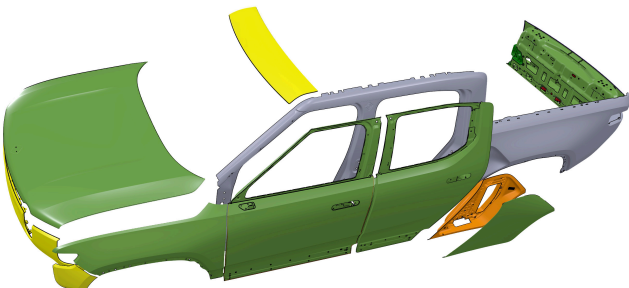
**Closures & Exterior Trim**

| Color Key | Material Type |
| | Conventional Steel |
| | Aluminum Sheet |
| | Magnesium |
| | Plastic |
